# Manhole Inspection Report

Date:	<b>03/23/2018</b>	Weather:		Coding:	<b>RZMACP</b>
MH#:	<b>M-902-045</b>	Owner:	<b>NA</b>	Len. Surveyed:	<b>11.2</b>
P.O.#:		Surveyor:	<b>John Kuglmaier</b>	Rim to Invert:	<b>12.4</b>
Customer:		Cert. #:	<b>U-1215-07002349</b>	Wall Material:	<b>Concrete (reinforced)</b>

Street:	<b>35th Ave. 88' East of St Joseph Pl.</b>	Project:	<b>Hobart, IN</b>
City:	<b>Hobart, IN</b>	GPS Northing:	<b>0.0</b>
Location:		GPS Easting:	<b>0.0</b>
Drain Area:	<b>Northeast</b>	GPS Accuracy:	<b>Nearest Meter</b>
Cover Shape:	<b>Circular</b>	Evidence of Surcharge:	<b>No</b>
Cover Size:	<b>23.0</b>	Potential for Runoff:	<b>None</b>
Comments:

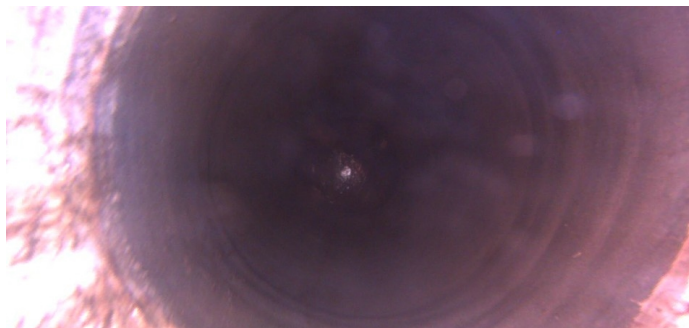
Code: **MGP**  
Description: **General Photo**

Distance (ft): **.0**  
Structural Grade: **0**  
O&M Grade: **0**  
Clock Start/From:  
Clock To:  
1st Value:  
2nd Value:  
Value Percent:  
Step: **NO**  
Remarks:

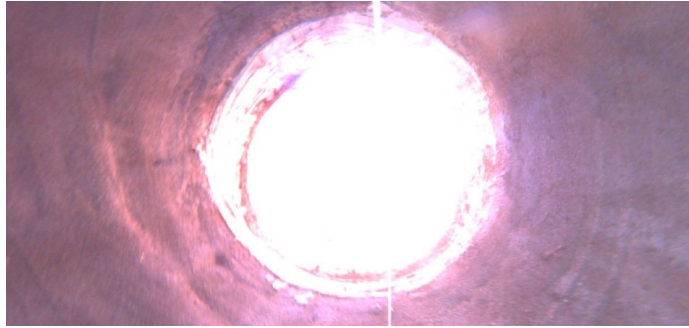
Code: **MGP**  
Description: **General Photo**

Distance (ft): **2.7**  
Structural Grade: **0**  
O&M Grade: **0**  
Clock Start/From:  
Clock To:  
1st Value:  
2nd Value:  
Value Percent:  
Step: **NO**  
Remarks:

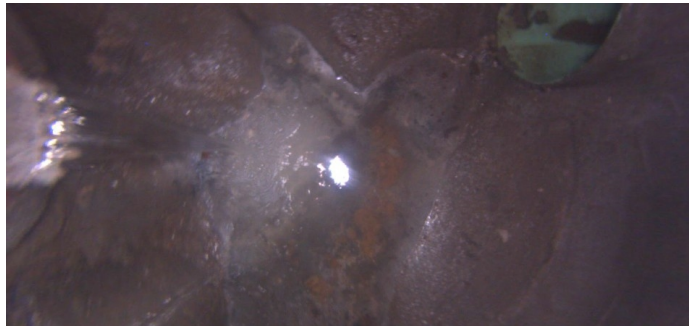
Code: **MGO**  
Description: **General Observation**

Distance (ft): **9.9**  
Structural Grade: **0**  
O&M Grade: **0**  
Clock Start/From:  
Clock To:  
1st Value:  
2nd Value:  
Value Percent:  
Step: **NO**  
Remarks: **Ins. Comp.**
