Manhole Inspection Report

Date:	03/23/2018	Weather:		Coding:	RZMACP
MH#:	M-902-046	Owner:	NA	Len. Surveyed:	11.3
P.O.#:		Surveyor:	John Kuglmaier	Rim to Invert:	12.5
Customer:		Cert. #:	U-1215-07002349	Wall Material:	Concrete (reinforced)

Street:	35th Ave. 127' West of St Joseph Pl.	Project:	Hobart, IN
City:	Hobart, IN	GPS Northing:	0.0
Location:		GPS Easting:	0.0
Drain Area:	Northeast	GPS Accuracy:	Nearest Meter
Cover Shape:	Circular	Evidence of Surcharge:	No
Cover Size:	23.0	Potential for Runoff:	None
Comments:

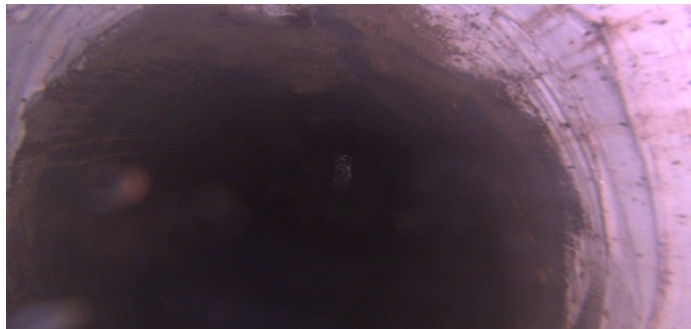
Code: **MGP**
 Description: **General Photo**

Distance (ft): **.0**
 Structural Grade: **0**
 O&M Grade: **0**
 Clock Start/From:
 Clock To:
 1st Value:
 2nd Value:
 Value Percent:
 Step: **NO**
 Remarks:

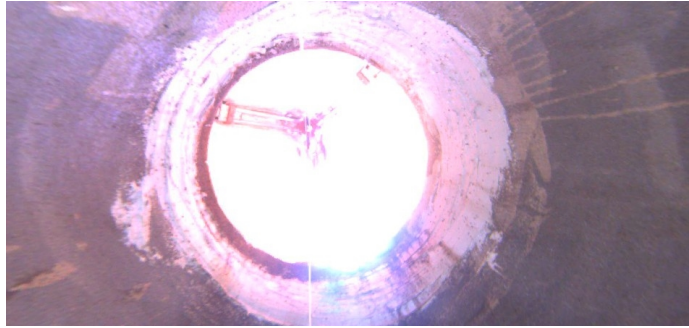
Code: **MGP**
Description: **General Photo**

Distance (ft): **2.6**
Structural Grade: **0**
O&M Grade: **0**
Clock Start/From:
Clock To:
1st Value:
2nd Value:
Value Percent:
Step: **NO**
Remarks:

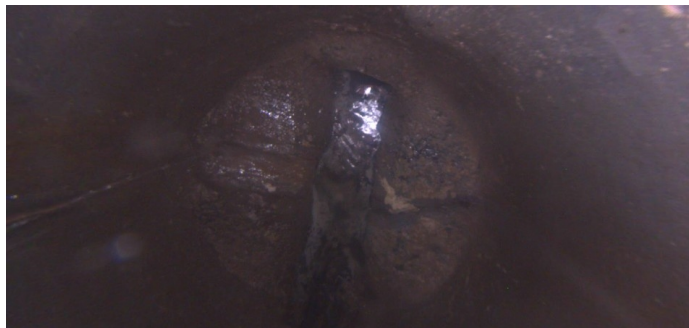
Code: **DSF**
Description: **Deposits Settled Fine**

Distance (ft): **7.8**
Structural Grade: **0**
O&M Grade: **2**
Clock Start/From: **12**
Clock To: **12**
1st Value:
2nd Value:
Value Percent: **10.000**
Step: **NO**
Remarks:

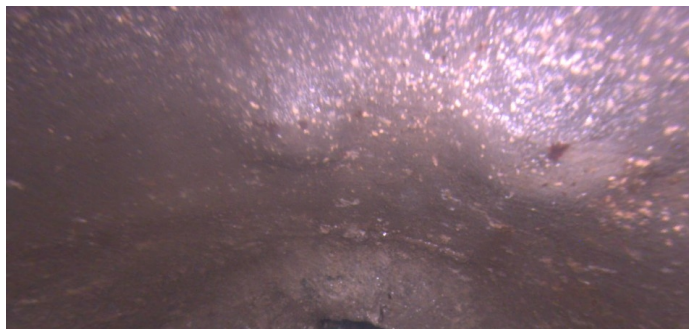
Code: **VC**
Description: **Vermin Cockroach**

Distance (ft): **9.3**
Structural Grade: **0**
O&M Grade: **1**
Clock Start/From:
Clock To:
1st Value:
2nd Value:
Value Percent:
Step: **NO**
Remarks:

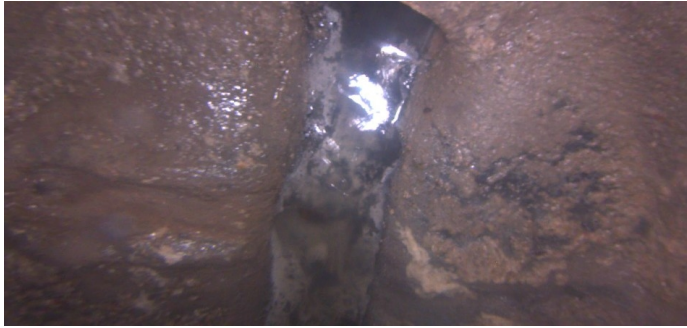
Code:	MGO
Description:	General Observation
Distance (ft):	10.0
Structural Grade:	0
O&M Grade:	0
Clock Start/From:	
Clock To:	
1st Value:	
2nd Value:	
Value Percent:	
Step:	NO
Remarks:	Ins. Comp.
