Manhole Inspection Report

Date:	03/23/2018	Weather:		Coding:	RZMACP
MH#:	M-902-048	Owner:	NA	Len. Surveyed:	4.6
P.O.#:		Surveyor:	John Kuglmaier	Rim to Invert:	6.0
Customer:		Cert. #:	U-1215-07002349	Wall Material:	Concrete (reinforced)

Street:	Intersection of Rush Pl. and 36th Av	Project:	Hobart, IN
City:	Hobart, IN	GPS Northing:	0.0
Location:		GPS Easting:	0.0
Drain Area:	Northeast	GPS Accuracy:	Nearest Meter
Cover Shape:	Circular	Evidence of Surcharge:	No
Cover Size:	23.0	Potential for Runoff:	None
Comments:

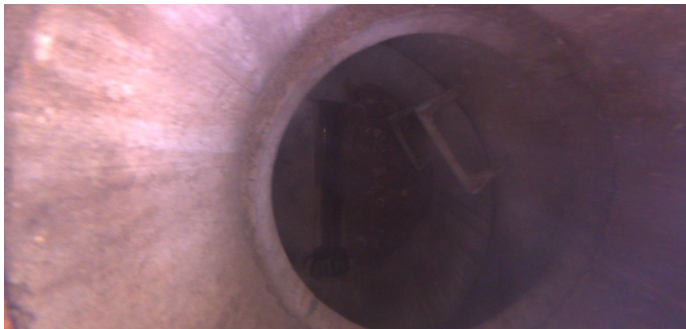
Code:	MGP
Description:	General Photo

Distance (ft):	.0
Structural Grade:	0
O&M Grade:	0
Clock Start/From:	
Clock To:	
1st Value:	
2nd Value:	
Value Percent:	
Step:	NO
Remarks:

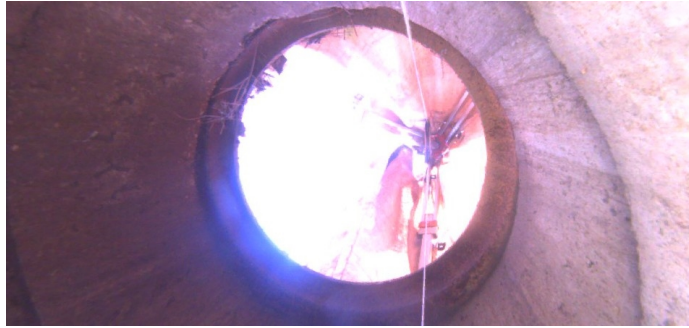
Code: **MGP**
Description: **General Photo**

Distance (ft): **2.1**
Structural Grade: **0**
O&M Grade: **0**
Clock Start/From:
Clock To:
1st Value:
2nd Value:
Value Percent:
Step: **NO**
Remarks:

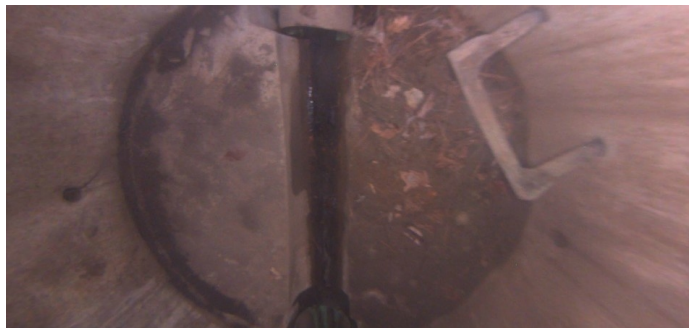
Code: **DAZ**
Description: **Deposits Attached Other**

Distance (ft): **2.7**
Structural Grade: **0**
O&M Grade: **2**
Clock Start/From: **12**
Clock To: **6**
1st Value:
2nd Value:
Value Percent: **5.000**
Step: **NO**
Remarks: **Mixed materials**

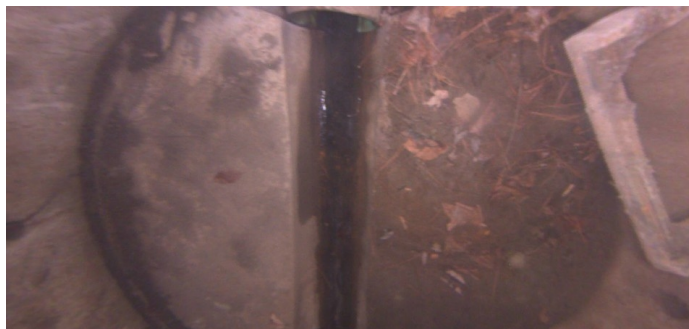
Code: **MGO**
Description: **General Observation**

Distance (ft): **3.5**
Structural Grade: **0**
O&M Grade: **0**
Clock Start/From:
Clock To:
1st Value:
2nd Value:
Value Percent:
Step: **NO**
Remarks: **Ins. Comp.**
