Manhole Inspection Report

Date:	03/23/2018	Weather:		Coding:	RZMACP
MH#:	M-902-053	Owner:	NA	Len. Surveyed:	5.4
P.O.#:		Surveyor:	John Kuglmaier	Rim to Invert:	6.4
Customer:		Cert. #:	U-1215-07002349	Wall Material:	Concrete (reinforced)

Street:	36th Ave. 101' West of St Joseph's Pl	Project:	Hobart, IN
City:	Hobart, IN	GPS Northing:	0.0
Location:		GPS Easting:	0.0
Drain Area:	Northeast	GPS Accuracy:	Nearest Meter
Cover Shape:	Circular	Evidence of Surcharge:	No
Cover Size:	23.0	Potential for Runoff:	None
Comments:

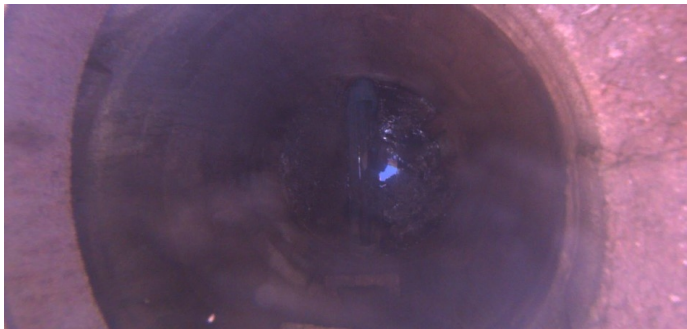
Code:	MGP
Description:	General Photo

Distance (ft):	.0
Structural Grade:	0
O&M Grade:	0
Clock Start/From:	
Clock To:	
1st Value:	
2nd Value:	
Value Percent:	
Step:	NO
Remarks:

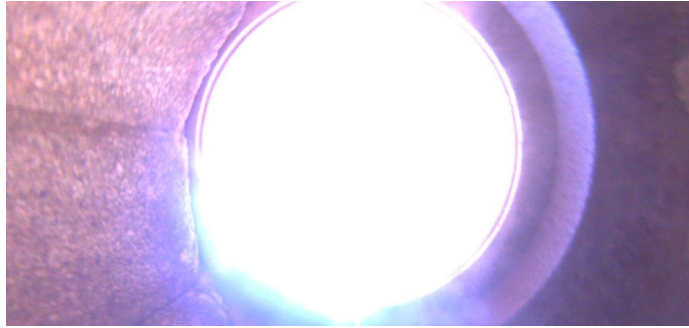
Code: **MGP**
Description: **General Photo**

Distance (ft): **2.0**
Structural Grade: **0**
O&M Grade: **0**
Clock Start/From:
Clock To:
1st Value:
2nd Value:
Value Percent:
Step: **NO**
Remarks:

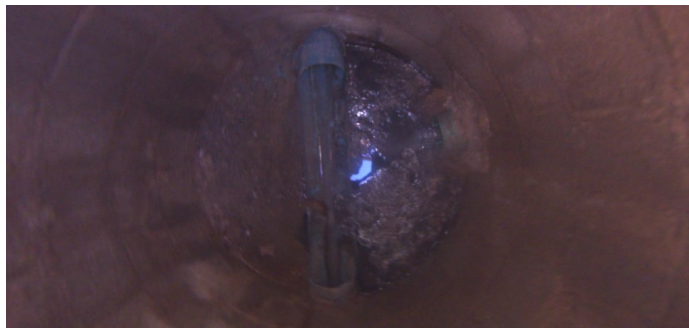
Code: **IS**
Description: **Infil Stain**

Distance (ft): **2.2**
Structural Grade: **0**
O&M Grade: **0**
Clock Start/From: **7**
Clock To: **11**
1st Value:
2nd Value:
Value Percent:
Step: **NO**
Remarks:

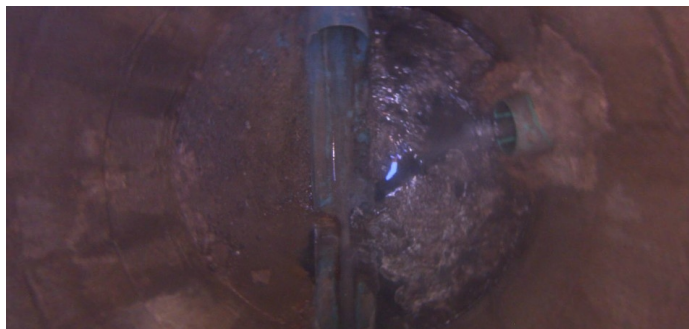
Code: **DAZ**
Description: **Deposits Attached Other**

Distance (ft): **3.2**
Structural Grade: **0**
O&M Grade: **2**
Clock Start/From: **12**
Clock To: **12**
1st Value:
2nd Value:
Value Percent: **5.000**
Step: **NO**
Remarks: **Mixed materials**

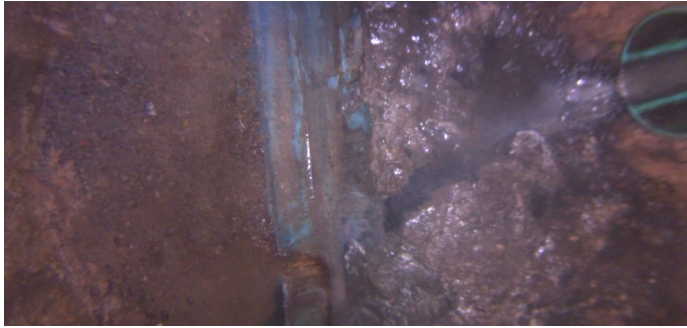
Code:	MGO
Description:	General Observation
Distance (ft):	4.5
Structural Grade:	0
O&M Grade:	0
Clock Start/From:	
Clock To:	
1st Value:	
2nd Value:	
Value Percent:	
Step:	NO
Remarks:	Ins. Comp.
