Manhole Inspection Report

Date:	03/23/2018	Weather:		Coding:	RZMACP
MH#:	M-902-056	Owner:	NA	Len. Surveyed:	10.2
P.O.#:		Surveyor:	John Kuglmaier	Rim to Invert:	12.0
Customer:		Cert. #:	U-1215-07002349	Wall Material:	Concrete (reinforced)

Street:	Rush Pl. 155' South of 34th Ln.	Project:	Hobart, IN
City:	Hobart, IN	GPS Northing:	0.0
Location:		GPS Easting:	0.0
Drain Area:	Northeast	GPS Accuracy:	Nearest Meter
Cover Shape:	Circular	Evidence of Surcharge:	Yes
Cover Size:	23.0	Potential for Runoff:	None
Comments:

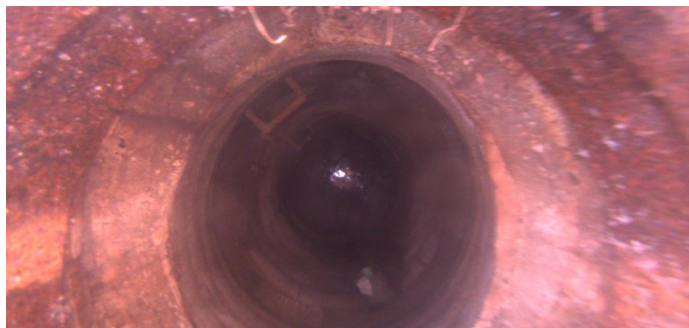
Code: **MGP**
Description: **General Photo**

Distance (ft): **.0**
Structural Grade: **0**
O&M Grade: **0**
Clock Start/From:
Clock To:
1st Value:
2nd Value:
Value Percent:
Step: **NO**
Remarks:

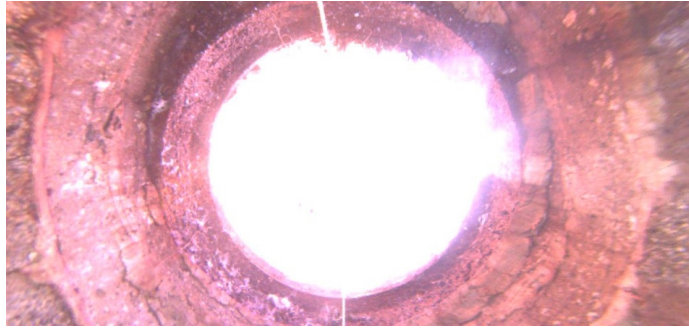
Code: **MGP**
Description: **General Photo**

Distance (ft): **2.3**
Structural Grade: **0**
O&M Grade: **0**
Clock Start/From:
Clock To:
1st Value:
2nd Value:
Value Percent:
Step: **NO**
Remarks:

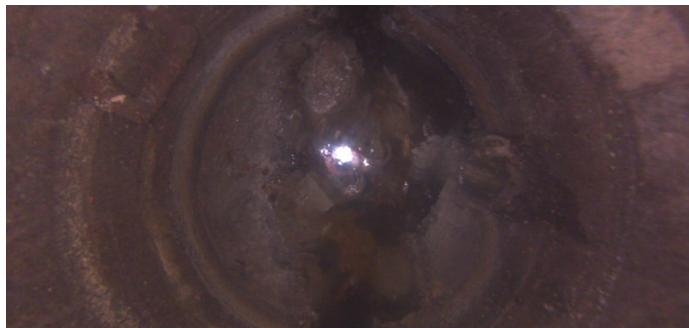
Code: **DAZ**
Description: **Deposits Attached Other**

Distance (ft): **7.2**
Structural Grade: **0**
O&M Grade: **3**
Clock Start/From: **12**
Clock To: **12**
1st Value:
2nd Value:
Value Percent: **20.000**
Step: **NO**
Remarks: **Mixed materials**

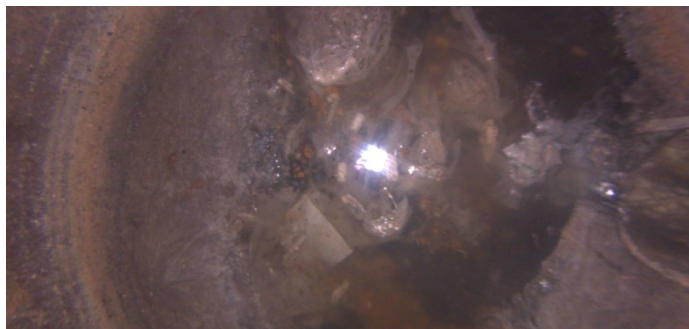
Code: **MGO**
Description: **General Observation**

Distance (ft): **9.0**
Structural Grade: **0**
O&M Grade: **0**
Clock Start/From:
Clock To:
1st Value:
2nd Value:
Value Percent:
Step: **NO**
Remarks: **Ins. Comp.**
