Manhole Inspection Report

Date:	03/23/2018	Weather:		Coding:	RZMACP
MH#:	M-902-059	Owner:	NA	Len. Surveyed:	6.9
P.O.#:		Surveyor:	John Kuglmaier	Rim to Invert:	7.9
Customer:		Cert. #:	U-1215-07002349	Wall Material:	Concrete (reinforced)

Street:	Intersection of Rush Pl. and 36th Av	Project:	Hobart, IN
City:	Hobart, IN	GPS Northing:	0.0
Location:		GPS Easting:	0.0
Drain Area:	Northeast	GPS Accuracy:	Nearest Meter
Cover Shape:	Circular	Evidence of Surcharge:	No
Cover Size:	23.0	Potential for Runoff:	None
Comments:

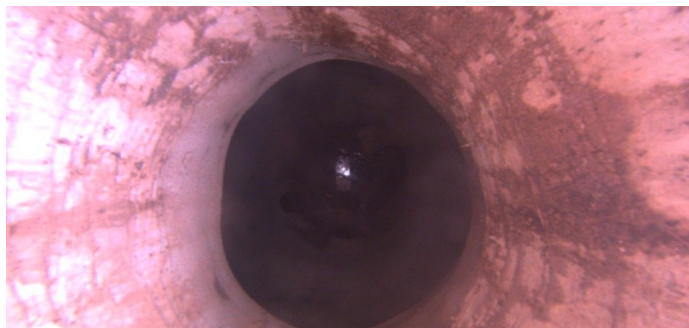
Code: **MGP**
Description: **General Photo**

Distance (ft): **.0**
Structural Grade: **0**
O&M Grade: **0**
Clock Start/From:
Clock To:
1st Value:
2nd Value:
Value Percent:
Step: **NO**
Remarks:

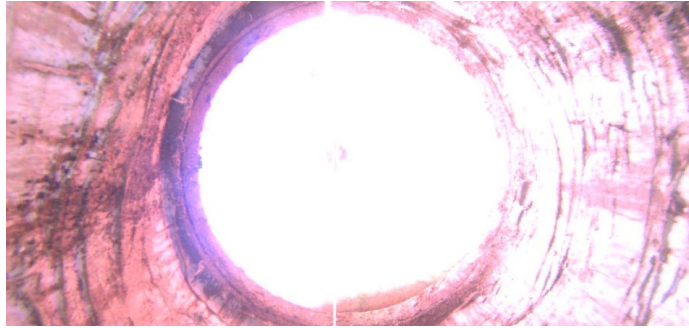
Code: **MGP**
Description: **General Photo**

Distance (ft): **1.8**
Structural Grade: **0**
O&M Grade: **0**
Clock Start/From:
Clock To:
1st Value:
2nd Value:
Value Percent:
Step: **NO**
Remarks:

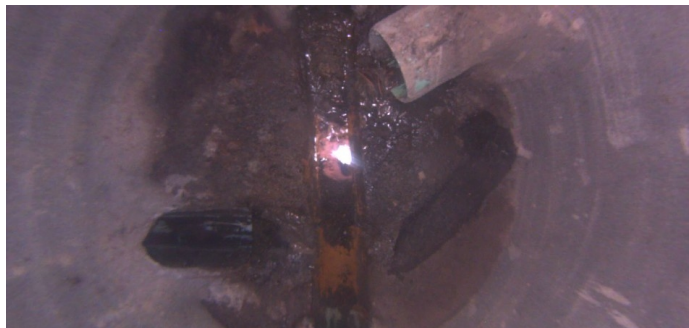
Code: **DSF**
Description: **Deposits Settled Fine**

Distance (ft): **4.7**
Structural Grade: **0**
O&M Grade: **2**
Clock Start/From: **12**
Clock To: **12**
1st Value:
2nd Value:
Value Percent: **10.000**
Step: **NO**
Remarks:

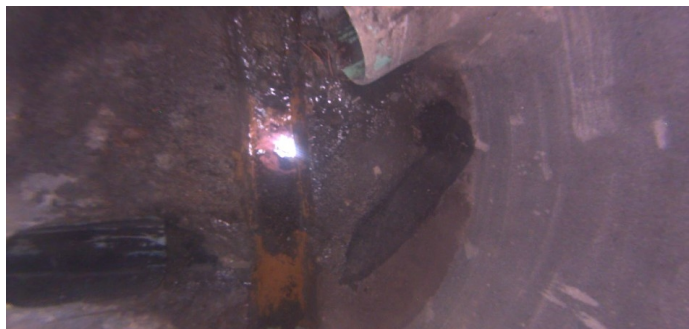
Code: **OBZ**
Description: **Obstacle Other**

Distance (ft): **5.2**
Structural Grade: **0**
O&M Grade: **2**
Clock Start/From: **3**
Clock To: **5**
1st Value:
2nd Value:
Value Percent: **5.000**
Step: **NO**
Remarks: **Wood**

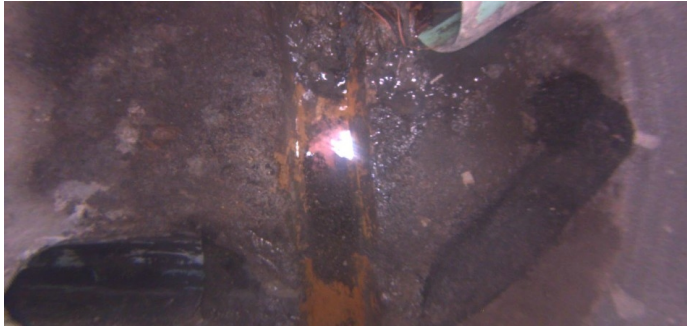
Code:	MGO
Description:	General Observation
Distance (ft):	5.8
Structural Grade:	0
O&M Grade:	0
Clock Start/From:	
Clock To:	
1st Value:	
2nd Value:	
Value Percent:	
Step:	NO
Remarks:	Ins. Comp.
