Manhole Inspection Report

Date:	03/21/2018	Weather:		Coding:	RZMACP
MH#:	M-902-065	Owner:	NA	Len. Surveyed:	5.8
P.O.#:		Surveyor:	John Kuglmaier	Rim to Invert:	7.0
Customer:		Cert. #:	U-1215-07002349	Wall Material:	Concrete (reinforced)

Street:	234' North of Hwy 6. West of Union	Project:	Hobart, IN
City:	Hobart, IN	GPS Northing:	0.0
Location:		GPS Easting:	0.0
Drain Area:	Northeast	GPS Accuracy:	Nearest Meter
Cover Shape:	Circular	Evidence of Surcharge:	No
Cover Size:	23.0	Potential for Runoff:	None
Comments:

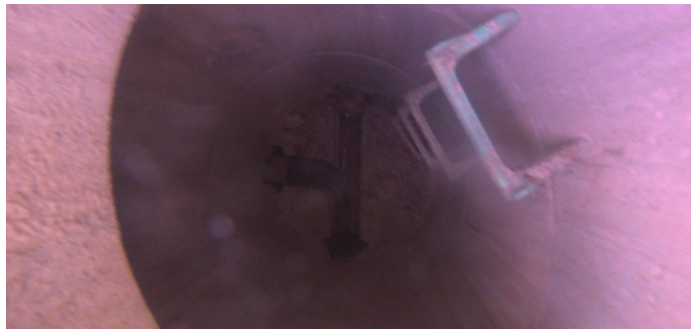
Code: **MGP**
Description: **General Photo**

Distance (ft): **.0**
Structural Grade: **0**
O&M Grade: **0**
Clock Start/From:
Clock To:
1st Value:
2nd Value:
Value Percent:
Step: **NO**
Remarks:

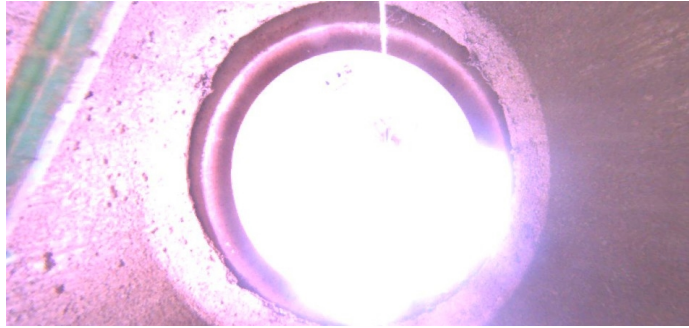
Code: **MGP**
Description: **General Photo**

Distance (ft): **2.1**
Structural Grade: **0**
O&M Grade: **0**
Clock Start/From:
Clock To:
1st Value:
2nd Value:
Value Percent:
Step: **NO**
Remarks:

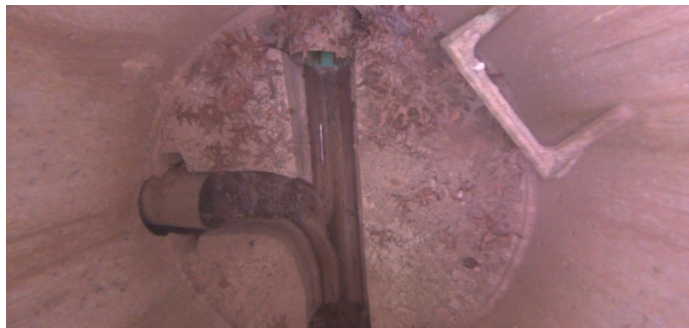
Code: **DAZ**
Description: **Deposits Attached Other**

Distance (ft): **3.5**
Structural Grade: **0**
O&M Grade: **2**
Clock Start/From: **12**
Clock To: **12**
1st Value:
2nd Value:
Value Percent: **5.000**
Step: **NO**
Remarks: **Mixed materials**

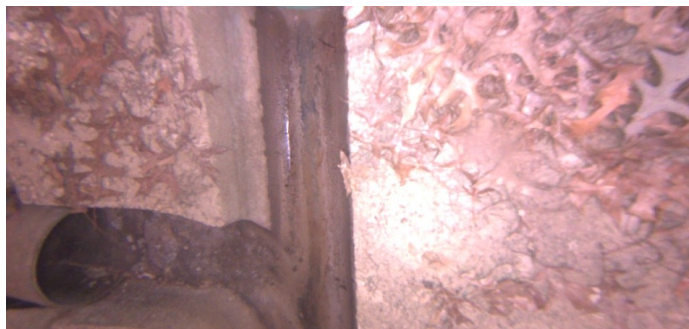
Code: **MGO**
Description: **General Observation**

Distance (ft): **5.1**
Structural Grade: **0**
O&M Grade: **0**
Clock Start/From:
Clock To:
1st Value:
2nd Value:
Value Percent:
Step: **NO**
Remarks: **Ins. Comp.**
