# Manhole Inspection Report

| MH#: | M-902-067 | Owner: | NA | Len. Surveyed: | 5.4 |

| Street: | South of 36th Ave. 231' East of Rush | Project: | Hobart, IN |

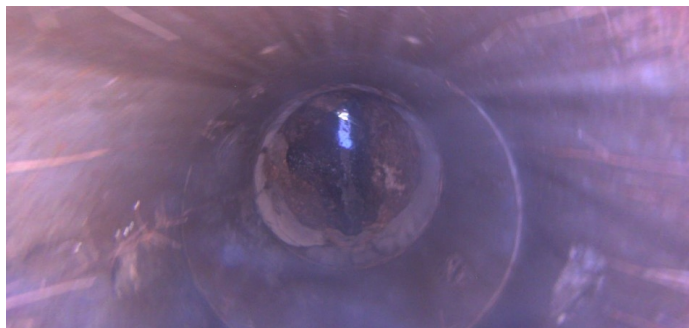
Code: **MGP**  
Description: **General Photo**

Distance (ft): **.0**  
Structural Grade: **0**  
O&M Grade: **0**  
Clock Start/From:  
Clock To:  
1st Value:  
2nd Value:  
Value Percent:  
Step: **NO**  
Remarks:

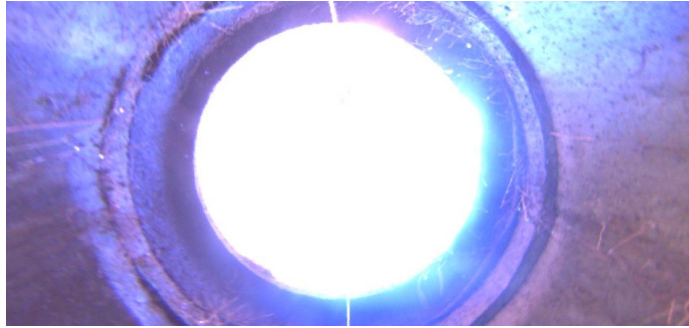
Code: **MGP**  
Description: **General Photo**

Distance (ft): **2.0**  
Structural Grade: **0**  
O&M Grade: **0**  
Clock Start/From:  
Clock To:  
1st Value:  
2nd Value:  
Value Percent:  
Step: **NO**  
Remarks:

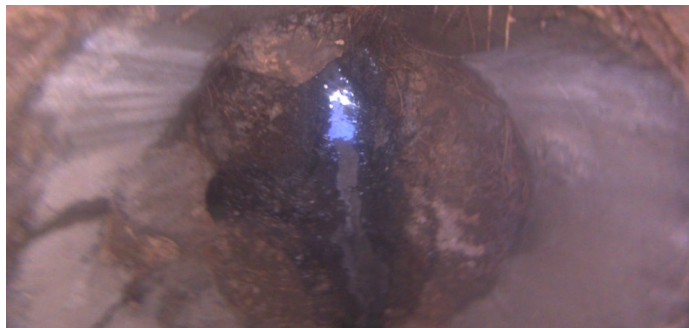
| | Position | Code | Observation | Video (sec) | Grade |
|--|---|---|---|---|---|
| | 3.5 | DAZ | Deposits Attached Other | 45 | M 2 |

Code: **DAZ**  
Description: **Deposits Attached Other**

Distance (ft): **3.5**  
Structural Grade: **0**  
O&M Grade: **2**  
Clock Start/From: **12**  
Clock To: **12**  
1st Value:  
2nd Value:  
Value Percent: **10.000**  
Step: **NO**  
Remarks: **Mixed materials**

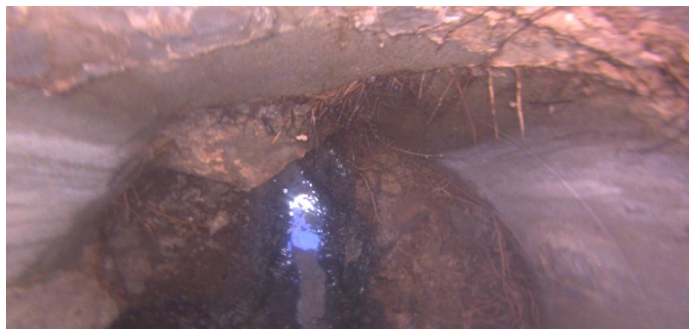
| | Position | Code | Observation | Video (sec) | Grade |
|--|---|---|---|---|---|
| | 3.8 | CM | Crack Multiple | 57 | S 3 |

Code: **CM**  
Description: **Crack Multiple**

Distance (ft): **3.8**  
Structural Grade: **3**  
O&M Grade: **0**  
Clock Start/From: **10**  
Clock To: **2**  
1st Value:  
2nd Value:  
Value Percent:  
Step: **NO**  
Remarks:

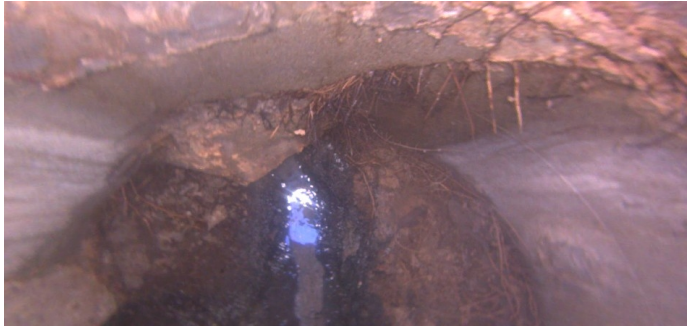
| | Position | Code | Observation | Video (sec) | Grade |
|--|---|---|---|---|---|
| | 3.8 | RFB | Roots Fine Barrel | 68 | M 2 |

Code: **RFB**  
Description: **Roots Fine Barrel**

Distance (ft): **3.8**  
Structural Grade: **0**  
O&M Grade: **2**  
Clock Start/From: **10**  
Clock To: **2**  
1st Value:  
2nd Value:  
Value Percent:  
Step: **NO**  
Remarks:

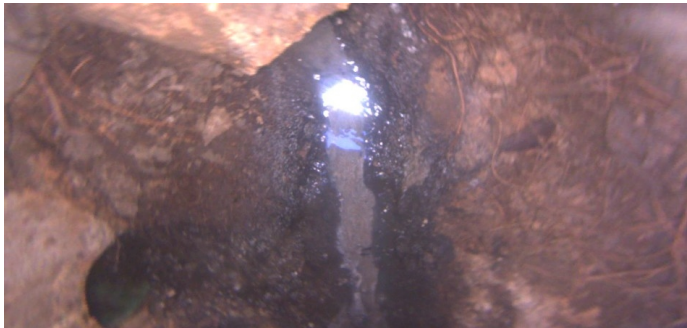
Code: **MGO**  
Description: **General Observation**

Distance (ft): **4.5**  
Structural Grade: **0**  
O&M Grade: **0**  
Clock Start/From:  
Clock To:  
1st Value:  
2nd Value:  
Value Percent:  
Step: **NO**  
Remarks: **Ins. Comp.**
