Manhole Inspection Report

Date:	03/25/2018	Weather:		Coding:	RZMACP
MH#:	M-902-068	Owner:	NA	Len. Surveyed:	7.3
P.O.#:		Surveyor:	John Kuglmaier	Rim to Invert:	8.0
Customer:		Cert. #:	U-1215-07002349	Wall Material:	Concrete (reinforced)

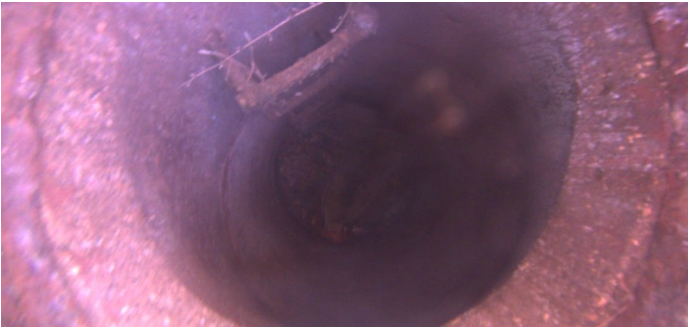
Code:

MGP

Description:

General Photo

Distance (ft):

.0

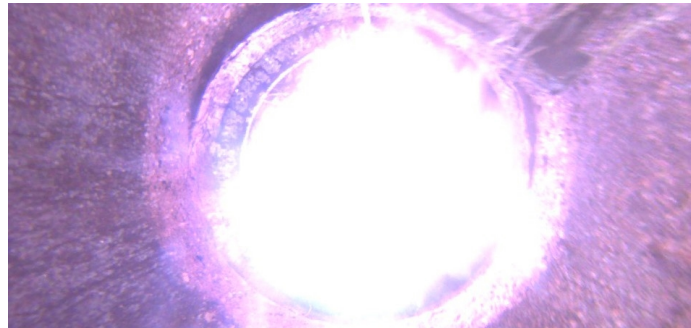
Code: **MGP**
Description: **General Photo**

Distance (ft): **2.4**
Structural Grade: **0**
O&M Grade: **0**
Clock Start/From:
Clock To:
1st Value:
2nd Value:
Value Percent:
Step: **NO**
Remarks:

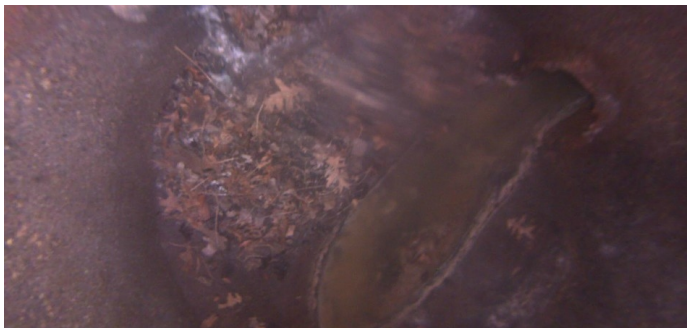
Code: **DAZ**
Description: **Deposits Attached Other**

Distance (ft): **5.5**
Structural Grade: **0**
O&M Grade: **2**
Clock Start/From: **12**
Clock To: **12**
1st Value:
2nd Value:
Value Percent: **10.000**
Step: **NO**
Remarks: **Mixed materials**

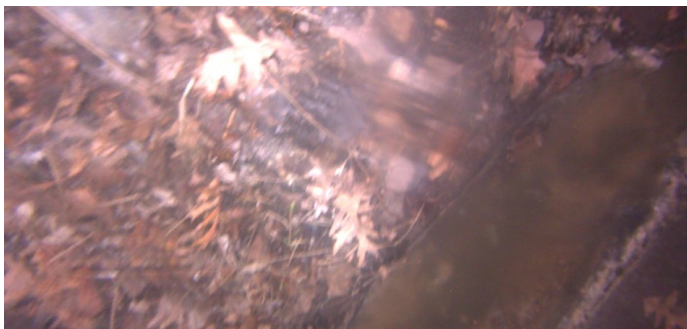
Code: **MGO**
Description: **General Observation**

Distance (ft): **6.6**
Structural Grade: **0**
O&M Grade: **0**
Clock Start/From:
Clock To:
1st Value:
2nd Value:
Value Percent:
Step: **NO**
Remarks: **Ins. Comp.**
