Manhole Inspection Report

Date:	03/23/2018	Weather:		Coding:	RZMACP
MH#:	M-902-071	Owner:	NA	Len. Surveyed:	2.8
P.O.#:		Surveyor:	John Kuglmaier	Rim to Invert:	3.6
Customer:		Cert. #:	U-1215-07002349	Wall Material:	Concrete (reinforced)

Street:	330' North of Intersection of 36th St	Project:	Hobart, IN
City:	Hobart, IN	GPS Northing:	0.0
Location:		GPS Easting:	0.0
Drain Area:	Northeast	GPS Accuracy:	Nearest Meter
Cover Shape:	Circular	Evidence of Surcharge:	No
Cover Size:	23.0	Potential for Runoff:	None
Comments:

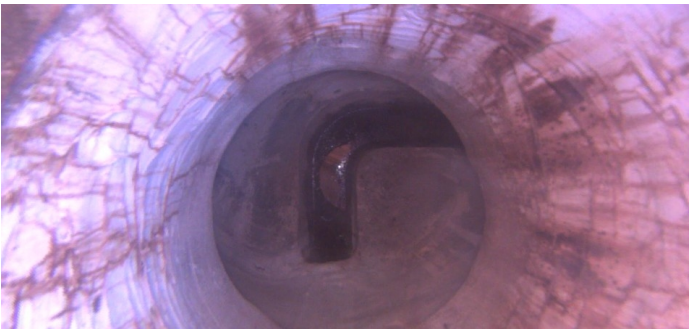
Code: **MGP**
Description: **General Photo**

Distance (ft): **.0**
Structural Grade: **0**
O&M Grade: **0**
Clock Start/From:
Clock To:
1st Value:
2nd Value:
Value Percent:
Step: **NO**
Remarks:

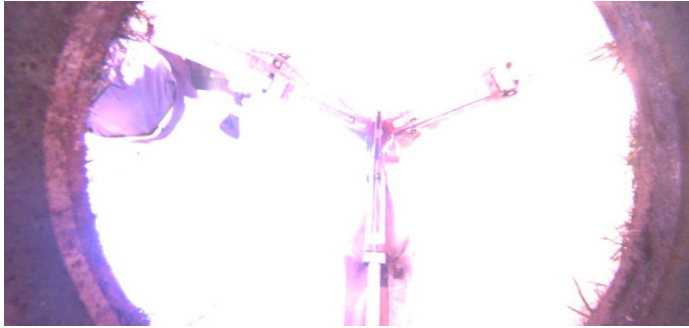
Code:	MGP
Description:	General Photo
Distance (ft):	1.2
Structural Grade:	0
O&M Grade:	0
Clock Start/From:	
Clock To:	
1st Value:	
2nd Value:	
Value Percent:	
Step:	NO
Remarks:

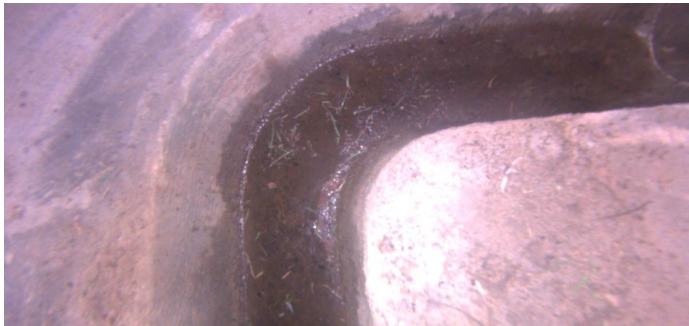
Code:	MGO
Description:	General Observation
Distance (ft):	2.3
Structural Grade:	0
O&M Grade:	0
Clock Start/From:	
Clock To:	
1st Value:	
2nd Value:	
Value Percent:	
Step:	NO
Remarks:	Ins. Comp.
