Manhole Inspection Report

Date:	03/23/2018	Weather:		Coding:	RZMACP
MH#:	M-902-076	Owner:	NA	Len. Surveyed:	9.9
P.O.#:		Surveyor:	John Kuglmaier	Rim to Invert:	11.0
Customer:		Cert. #:	U-1215-07002349	Wall Material:	Concrete (reinforced)

Street:	Intersection of 34th Ln and Saint Jos	Project:	Hobart, IN
City:	Hobart, IN	GPS Northing:	0.0
Location:		GPS Easting:	0.0
Drain Area:	Northeast	GPS Accuracy:	Nearest Meter
Cover Shape:	Circular	Evidence of Surcharge:	Yes
Cover Size:	23.0	Potential for Runoff:	None
Comments:

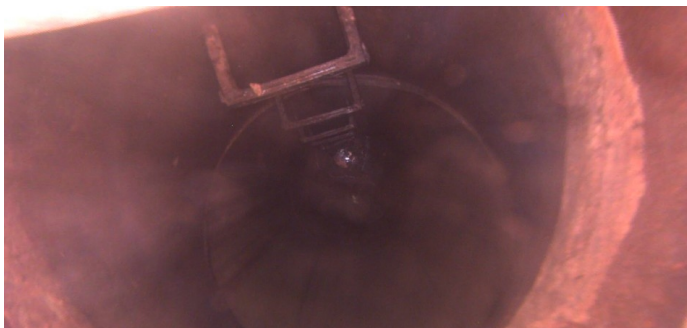
Code: **MGP**
Description: **General Photo**

Distance (ft): **.0**
Structural Grade: **0**
O&M Grade: **0**
Clock Start/From:
Clock To:
1st Value:
2nd Value:
Value Percent:
Step: **NO**
Remarks:

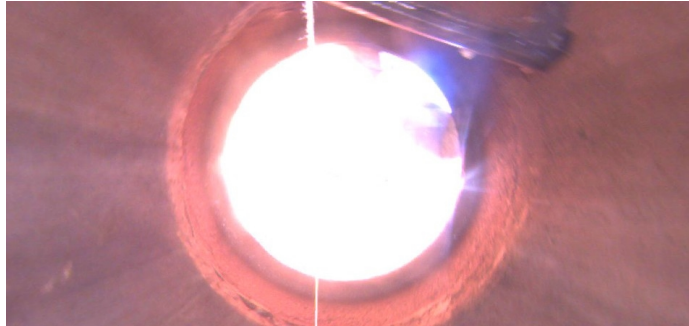
Code: **MGP**
Description: **General Photo**

Distance (ft): **2.6**
Structural Grade: **0**
O&M Grade: **0**
Clock Start/From:
Clock To:
1st Value:
2nd Value:
Value Percent:
Step: **NO**
Remarks:

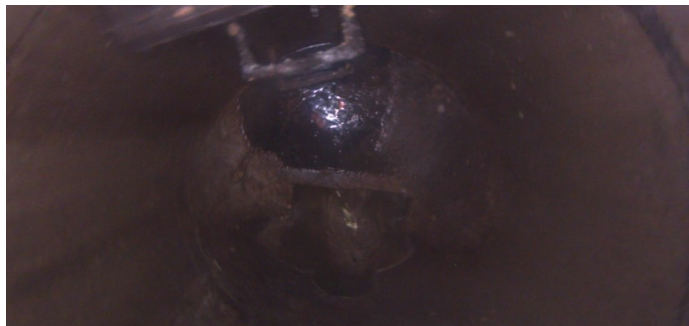
Code: **DAZ**
Description: **Deposits Attached Other**

Distance (ft): **7.1**
Structural Grade: **0**
O&M Grade: **2**
Clock Start/From: **12**
Clock To: **12**
1st Value:
2nd Value:
Value Percent: **5.000**
Step: **NO**
Remarks: **Mixed materials**

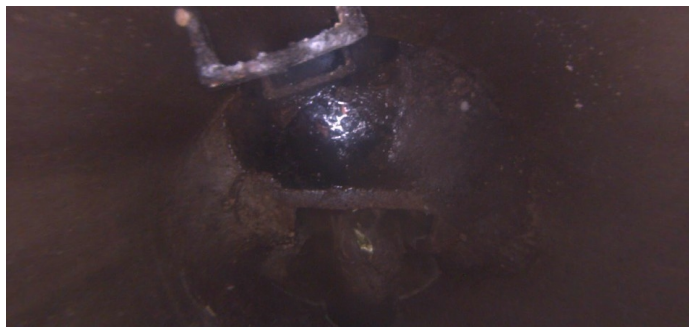
Code: **MGO**
Description: **General Observation**

Distance (ft): **7.8**
Structural Grade: **0**
O&M Grade: **0**
Clock Start/From:
Clock To:
1st Value:
2nd Value:
Value Percent:
Step: **NO**
Remarks: **Surcharge**

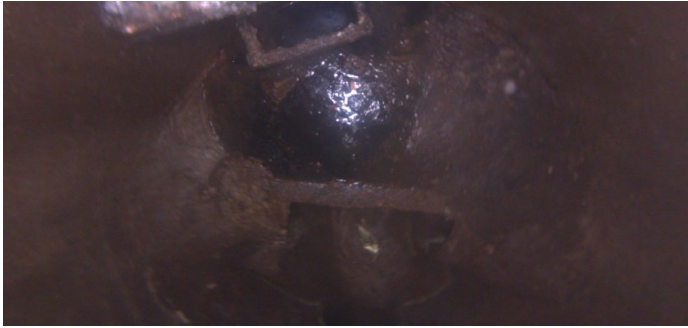
Code:	MGO
Description:	General Observation
Distance (ft):	8.4
Structural Grade:	0
O&M Grade:	0
Clock Start/From:	
Clock To:	
1st Value:	
2nd Value:	
Value Percent:	
Step:	NO
Remarks:	Ins. Comp.
