# Manhole Inspection Report

Date:	<b>03/23/2018</b>	Weather:		Coding:	<b>RZMACP</b>
MH#:	<b>M-902-077</b>	Owner:	<b>NA</b>	Len. Surveyed:	<b>10.1</b>
P.O.#:		Surveyor:	<b>John Kuglmaier</b>	Rim to Invert:	<b>11.5</b>
Customer:		Cert. #:	<b>U-1215-07002349</b>	Wall Material:	<b>Concrete (reinforced)</b>

Street:	<b>Intersection of 34th Ln and Saint Jos</b>	Project:	<b>Hobart, IN</b>
City:	<b>Hobart, IN</b>	GPS Northing:	<b>0.0</b>
Location:		GPS Easting:	<b>0.0</b>
Drain Area:	<b>Northeast</b>	GPS Accuracy:	<b>Nearest Meter</b>
Cover Shape:	<b>Circular</b>	Evidence of Surcharge:	<b>No</b>
Cover Size:	<b>23.0</b>	Potential for Runoff:	<b>None</b>
Comments:

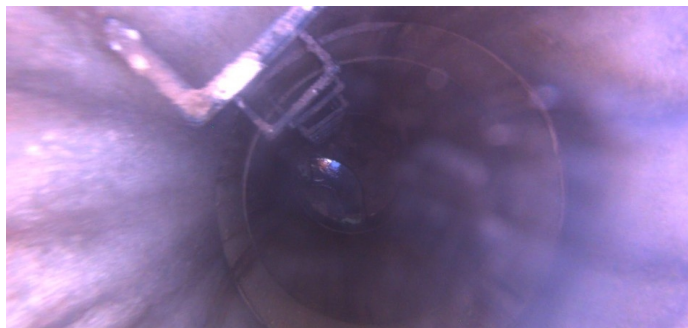
Code: **MGP**  
Description: **General Photo**

Distance (ft): **.0**  
Structural Grade: **0**  
O&M Grade: **0**  
Clock Start/From:  
Clock To:  
1st Value:  
2nd Value:  
Value Percent:  
Step: **NO**  
Remarks:

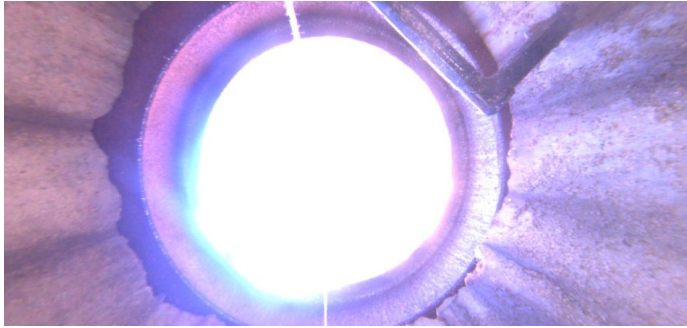
Code: **MGP**  
Description: **General Photo**

Distance (ft): **2.3**  
Structural Grade: **0**  
O&M Grade: **0**  
Clock Start/From:  
Clock To:  
1st Value:  
2nd Value:  
Value Percent:  
Step: **NO**  
Remarks:

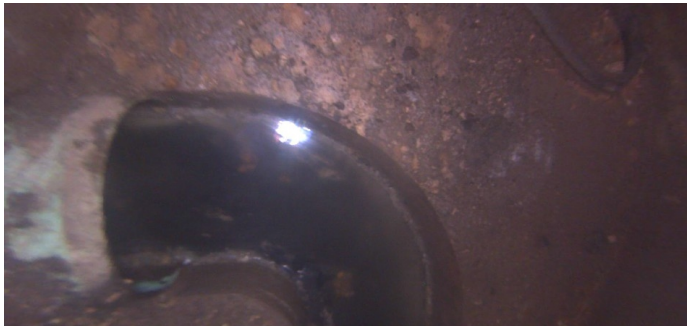
Code: **MGO**  
Description: **General Observation**

Distance (ft): **9.0**  
Structural Grade: **0**  
O&M Grade: **0**  
Clock Start/From:  
Clock To:  
1st Value:  
2nd Value:  
Value Percent:  
Step: **NO**  
Remarks: **Ins. Comp.**
