Manhole Inspection Report

Date:	03/23/2018	Weather:		Coding:	RZMACP
MH#:	M-902-078	Owner:	NA	Len. Surveyed:	10.5
P.O.#:		Surveyor:	John Kuglmaier	Rim to Invert:	12.6
Customer:		Cert. #:	U-1215-07002349	Wall Material:	Concrete (reinforced)

Street:	Intersection of 34th Ln and Saint Jos	Project:	Hobart, IN
City:	Hobart, IN	GPS Northing:	0.0
Location:		GPS Easting:	0.0
Drain Area:	Northeast	GPS Accuracy:	Nearest Meter
Cover Shape:	Circular	Evidence of Surcharge:	No
Cover Size:	23.0	Potential for Runoff:	None
Comments:

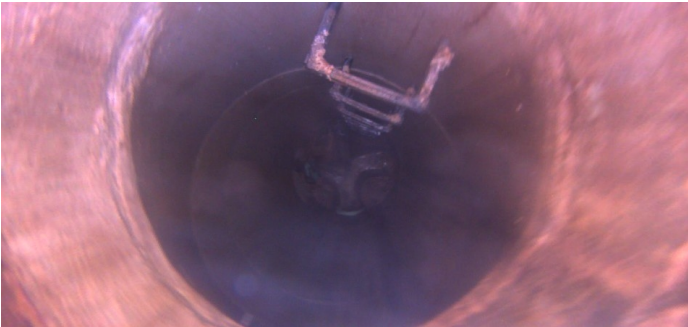
MGP

General Photo

.0

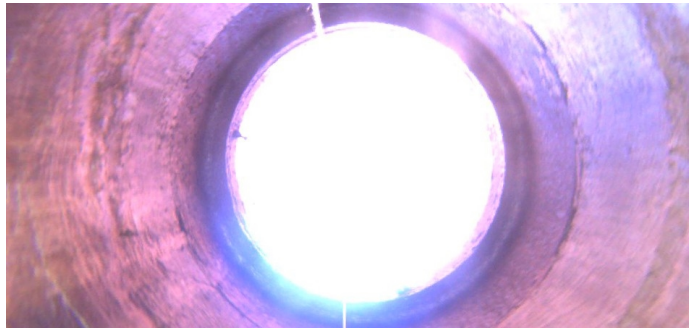
Code: **MGP**
Description: **General Photo**

Distance (ft): **2.3**
Structural Grade: **0**
O&M Grade: **0**
Clock Start/From:
Clock To:
1st Value:
2nd Value:
Value Percent:
Step: **NO**
Remarks:

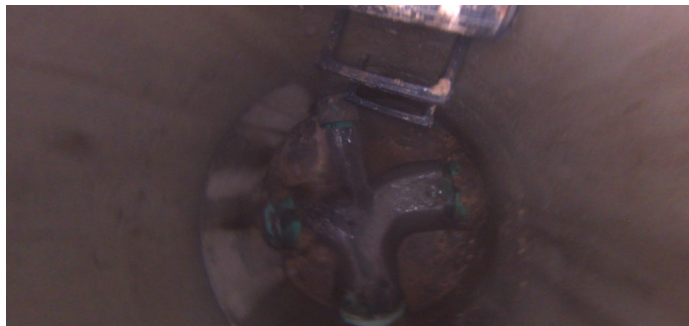
Code: **IS**
Description: **Infil Stain**

Distance (ft): **6.8**
Structural Grade: **0**
O&M Grade: **0**
Clock Start/From: **9**
Clock To: **10**
1st Value:
2nd Value:
Value Percent:
Step: **NO**
Remarks:

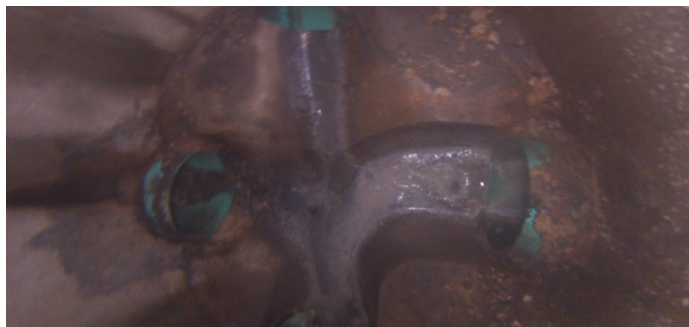
Code: **MGO**
Description: **General Observation**

Distance (ft): **9.2**
Structural Grade: **0**
O&M Grade: **0**
Clock Start/From:
Clock To:
1st Value:
2nd Value:
Value Percent:
Step: **NO**
Remarks: **Ins. Comp.**
