Manhole Inspection Report

Date:	03/23/2018	Weather:		Coding:	RZMACP
MH#:	M-902-079	Owner:	NA	Len. Surveyed:	10.6
P.O.#:		Surveyor:	John Kuglmaier	Rim to Invert:	11.7
Customer:		Cert. #:	U-1215-07002349	Wall Material:	Concrete (reinforced)

Street:	330' North of Intersection of 36th St	Project:	Hobart, IN
City:	Hobart, IN	GPS Northing:	0.0
Location:		GPS Easting:	0.0
Drain Area:	Northeast	GPS Accuracy:	Nearest Meter
Cover Shape:	Circular	Evidence of Surcharge:	No
Cover Size:	23.0	Potential for Runoff:	None
Comments:

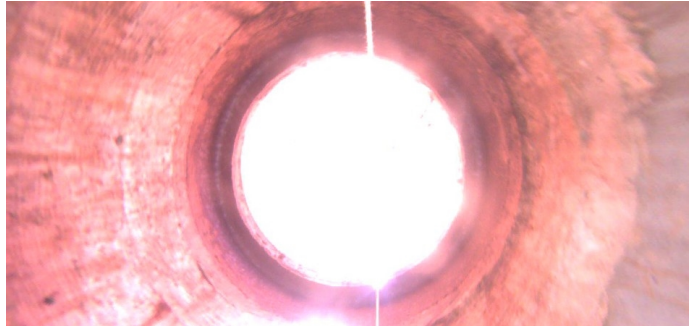
Code: **MGP**
Description: **General Photo**

Distance (ft): **2.7**
Structural Grade: **0**
O&M Grade: **0**
Clock Start/From:
Clock To:
1st Value:
2nd Value:
Value Percent:
Step: **NO**
Remarks:

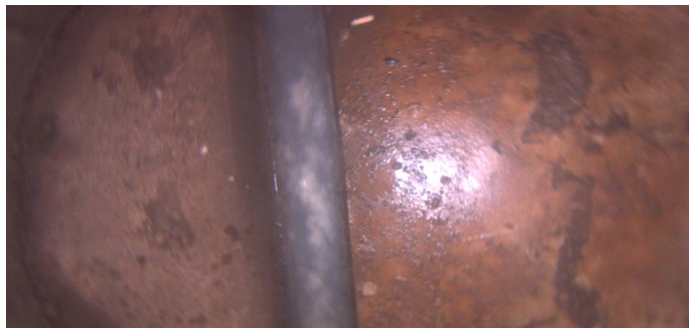
Code: **MGO**
Description: **General Observation**

Distance (ft): **9.8**
Structural Grade: **0**
O&M Grade: **0**
Clock Start/From:
Clock To:
1st Value:
2nd Value:
Value Percent:
Step: **NO**
Remarks: **Ins. Comp.**
