Manhole Inspection Report

Date:	03/23/2018	Weather:		Coding:	RZMACP
MH#:	M-902-080	Owner:	NA	Len. Surveyed:	9.7
P.O.#:		Surveyor:	John Kuglmaier	Rim to Invert:	11.0
Customer:		Cert. #:	U-1215-07002349	Wall Material:	Concrete (reinforced)

Street:	36th Ave. 101' West of St Joseph's Pl	Project:	Hobart, IN
City:	Hobart, IN	GPS Northing:	0.0
Location:		GPS Easting:	0.0
Drain Area:	Northeast	GPS Accuracy:	Nearest Meter
Cover Shape:	Circular	Evidence of Surcharge:	No
Cover Size:	23.0	Potential for Runoff:	None
Comments:

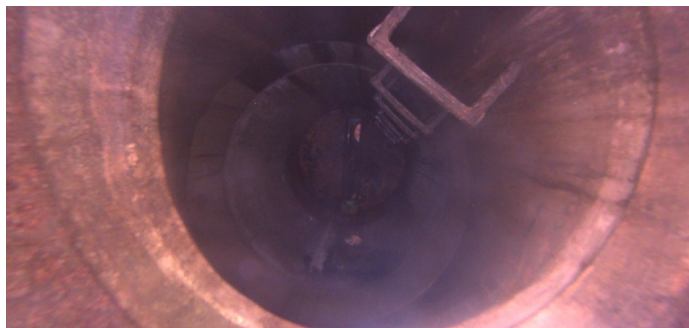
Code: **MGP**
Description: **General Photo**

Distance (ft): **.0**
Structural Grade: **0**
O&M Grade: **0**
Clock Start/From:
Clock To:
1st Value:
2nd Value:
Value Percent:
Step: **NO**
Remarks:

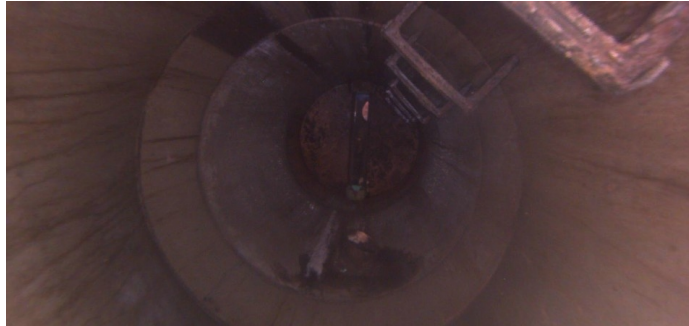
Code: **IS**
Description: **Infil Stain**

Distance (ft): **1.1**
Structural Grade: **0**
O&M Grade: **0**
Clock Start/From: **5**
Clock To: **7**
1st Value:
2nd Value:
Value Percent:
Step: **NO**
Remarks:

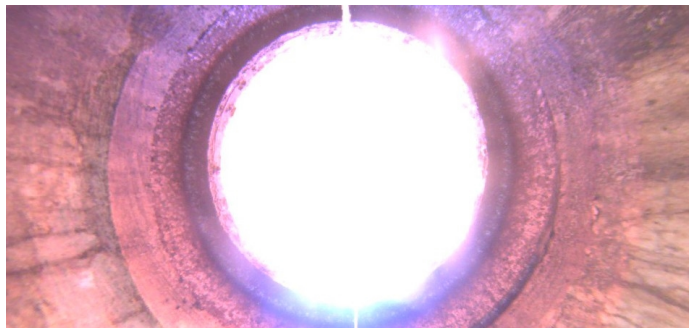
Code: **MGP**
Description: **General Photo**

Distance (ft): **2.1**
Structural Grade: **0**
O&M Grade: **0**
Clock Start/From:
Clock To:
1st Value:
2nd Value:
Value Percent:
Step: **NO**
Remarks:

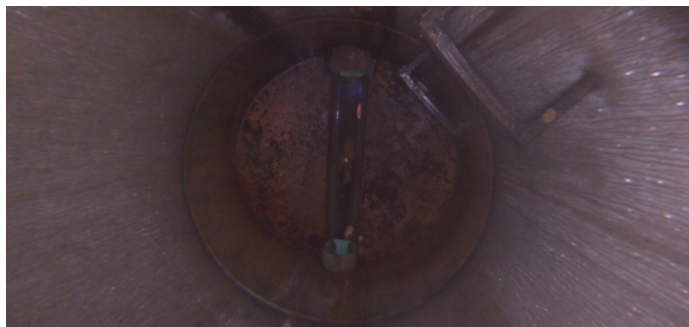
Code: **IS**
Description: **Infil Stain**

Distance (ft): **5.4**
Structural Grade: **0**
O&M Grade: **0**
Clock Start/From: **12**
Clock To: **12**
1st Value:
2nd Value:
Value Percent:
Step: **NO**
Remarks:

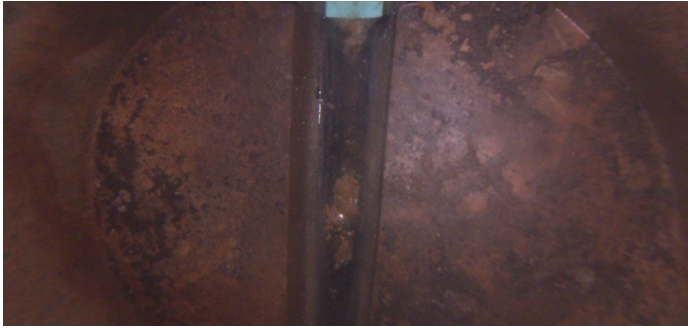
Code:	MGO
Description:	General Observation
Distance (ft):	8.5
Structural Grade:	0
O&M Grade:	0
Clock Start/From:	
Clock To:	
1st Value:	
2nd Value:	
Value Percent:	
Step:	NO
Remarks:	Ins. Comp.
