Manhole Inspection Report

Date:	03/23/2018	Weather:		Coding:	RZMACP
MH#:	M-902-081	Owner:	NA	Len. Surveyed:	9.3
P.O.#:		Surveyor:	John Kuglmaier	Rim to Invert:	10.7
Customer:		Cert. #:	U-1215-07002349	Wall Material:	Concrete (reinforced)

Street:	36th Ave. 101' West of St Joseph's Pl	Project:	Hobart, IN
City:	Hobart, IN	GPS Northing:	0.0
Location:		GPS Easting:	0.0
Drain Area:	Northeast	GPS Accuracy:	Nearest Meter
Cover Shape:	Circular	Evidence of Surcharge:	No
Cover Size:	23.0	Potential for Runoff:	None
Comments:

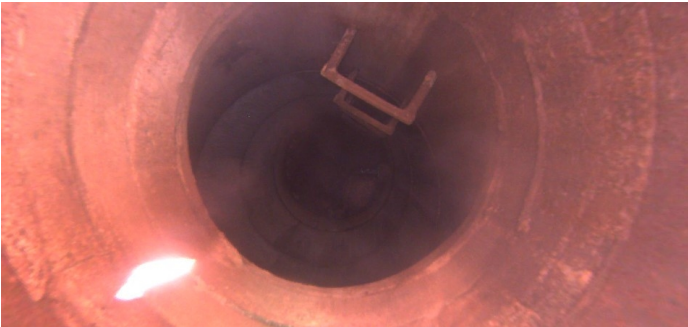
MGP

General Photo

.0

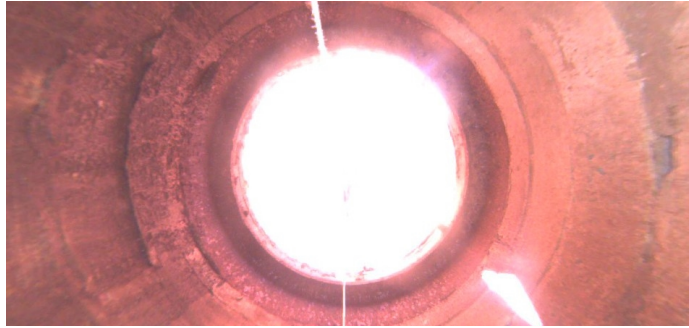
Code: **MGP**
Description: **General Photo**

Distance (ft): **2.7**
Structural Grade: **0**
O&M Grade: **0**
Clock Start/From:
Clock To:
1st Value:
2nd Value:
Value Percent:
Step: **NO**
Remarks:

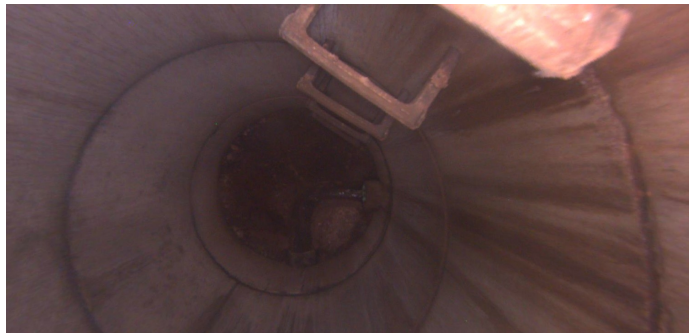
Code: **IS**
Description: **Infil Stain**

Distance (ft): **3.4**
Structural Grade: **0**
O&M Grade: **0**
Clock Start/From: **1**
Clock To: **5**
1st Value:
2nd Value:
Value Percent:
Step: **NO**
Remarks:

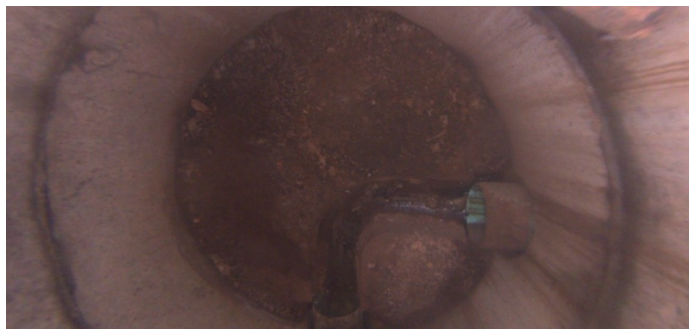
Code: **DSF**
Description: **Deposits Settled Fine**

Distance (ft): **7.4**
Structural Grade: **0**
O&M Grade: **2**
Clock Start/From: **12**
Clock To: **12**
1st Value:
2nd Value:
Value Percent: **5.000**
Step: **NO**
Remarks:

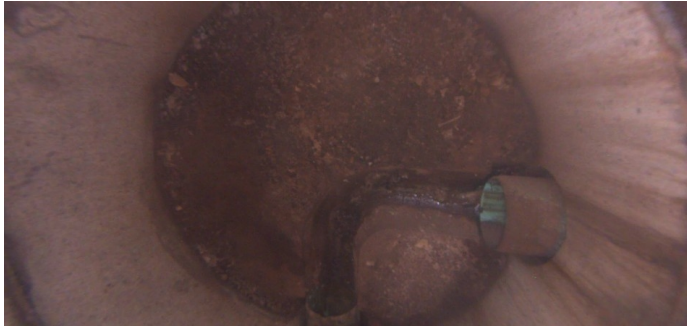
Code:	MGO
Description:	General Observation
Distance (ft):	7.8
Structural Grade:	0
O&M Grade:	0
Clock Start/From:	
Clock To:	
1st Value:	
2nd Value:	
Value Percent:	
Step:	NO
Remarks:	Ins. Comp.
