Manhole Inspection Report

Date:	03/20/2018	Weather:		Coding:	RZMACP
MH#:	M-903-003	Owner:	NA	Len. Surveyed:	1.8
P.O.#:		Surveyor:	John Kuglmaier	Rim to Invert:	3.0
Customer:		Cert. #:	U-1215-07002349	Wall Material:	Concrete (reinforced)

Street:	Shelby Pl. 97' North of 38th Pl.	Project:	Hobart, IN
City:	Hobart, IN	GPS Northing:	0.0
Location:		GPS Easting:	0.0
Drain Area:	Northeast	GPS Accuracy:	Nearest Meter
Cover Shape:	Circular	Evidence of Surcharge:	Yes
Cover Size:	23.0	Potential for Runoff:	None
Comments:

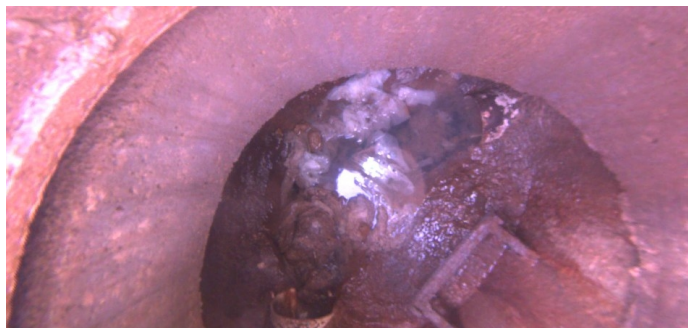
Code: **MGP**
Description: **General Photo**

Distance (ft): **.0**
Structural Grade: **0**
O&M Grade: **0**
Clock Start/From:
Clock To:
1st Value:
2nd Value:
Value Percent:
Step: **NO**
Remarks:

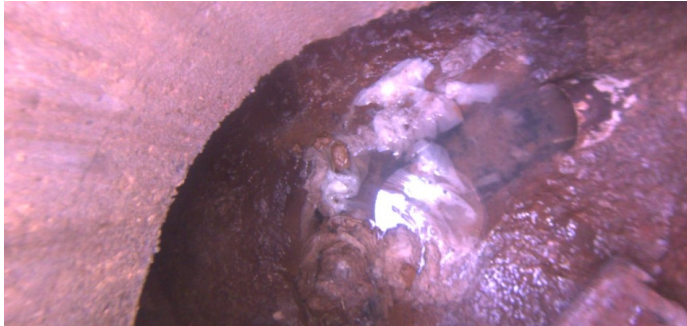
Code:	DAZ
Description:	Deposits Attached Other
Distance (ft):	.6
Structural Grade:	0
O&M Grade:	2
Clock Start/From:	12
Clock To:	12
1st Value:	
2nd Value:	
Value Percent:	10.000
Step:	NO
Remarks:	Mixed materials

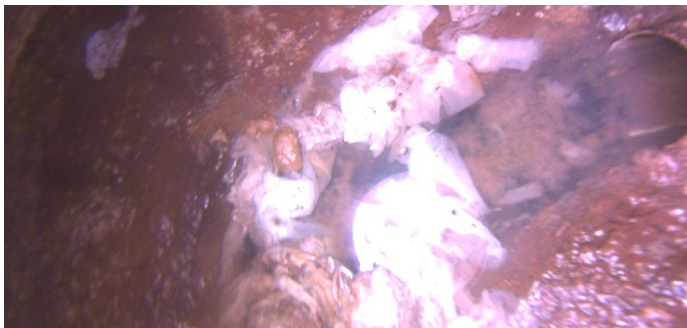
Code:	MGO
Description:	General Observation
Distance (ft):	1.4
Structural Grade:	0
O&M Grade:	0
Clock Start/From:	
Clock To:	
1st Value:	
2nd Value:	
Value Percent:	
Step:	NO
Remarks:	Ins. Comp.
