Manhole Inspection Report

Date:	03/24/2018	Weather:		Coding:	RZMACP
MH#:	M-903-003	Owner:	NA	Len. Surveyed:	6.6
P.O.#:		Surveyor:	John Kuglmaier	Rim to Invert:	7.6
Customer:		Cert. #:	U-1215-07002349	Wall Material:	Concrete (reinforced)

Street:	Shelby Pl. 97' North of 38th Pl.	Project:	Hobart, IN
City:	Hobart, IN	GPS Northing:	0.0
Location:		GPS Easting:	0.0
Drain Area:	Northeast	GPS Accuracy:	Nearest Meter
Cover Shape:	Circular	Evidence of Surcharge:	Yes
Cover Size:	23.0	Potential for Runoff:	None
Comments:

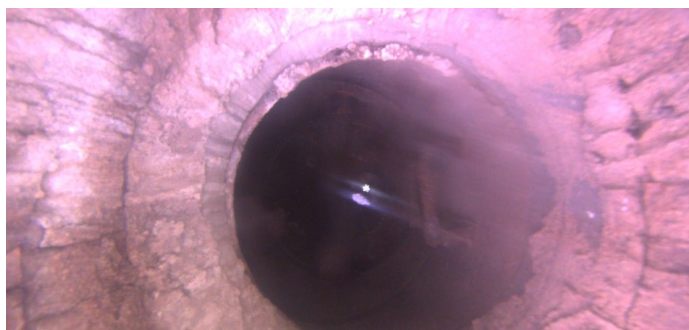
Code: **MGP**
Description: **General Photo**

Distance (ft): **.0**
Structural Grade: **0**
O&M Grade: **0**
Clock Start/From:
Clock To:
1st Value:
2nd Value:
Value Percent:
Step: **NO**
Remarks:

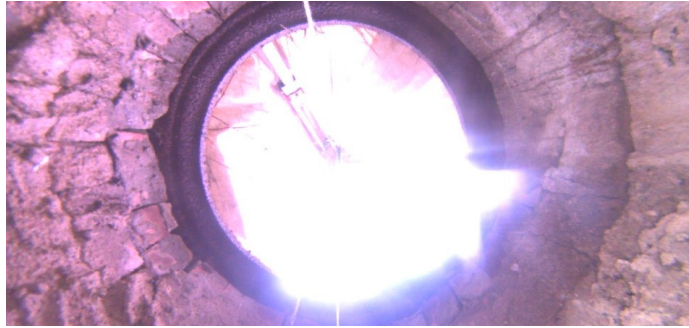
Code: **MGP**
Description: **General Photo**

Distance (ft): **2.1**
Structural Grade: **0**
O&M Grade: **0**
Clock Start/From:
Clock To:
1st Value:
2nd Value:
Value Percent:
Step: **NO**
Remarks:

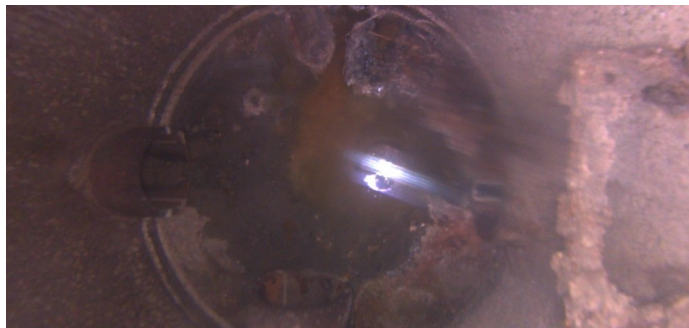
Code: **MGO**
Description: **General Observation**

Distance (ft): **4.2**
Structural Grade: **0**
O&M Grade: **0**
Clock Start/From:
Clock To:
1st Value:
2nd Value:
Value Percent:
Step: **NO**
Remarks: **Surcharge**

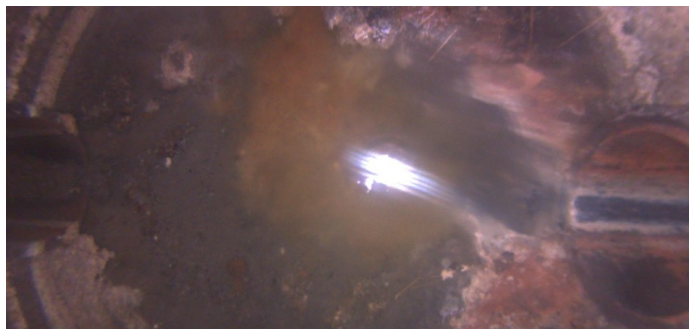
Code: **MGO**
Description: **General Observation**

Distance (ft): **5.4**
Structural Grade: **0**
O&M Grade: **0**
Clock Start/From:
Clock To:
1st Value:
2nd Value:
Value Percent:
Step: **NO**
Remarks: **Ins. Comp.**
