Manhole Inspection Report

Date:	03/20/2018	Weather:		Coding:	RZMACP
MH#:	M-903-004	Owner:	NA	Len. Surveyed:	2.8
P.O.#:		Surveyor:	John Kuglmaier	Rim to Invert:	4.0
Customer:		Cert. #:	U-1215-07002349	Wall Material:	Concrete (reinforced)

Street:	Intersection of Shelby Pl. and 38th A	Project:	Hobart, IN
City:	Hobart, IN	GPS Northing:	2911202.69
Location:		GPS Easting:	2911202.69
Drain Area:	Northeast	GPS Accuracy:	Sub-Meter
Cover Shape:	Circular	Evidence of Surcharge:	Yes
Cover Size:	23.0	Potential for Runoff:	None
Comments:

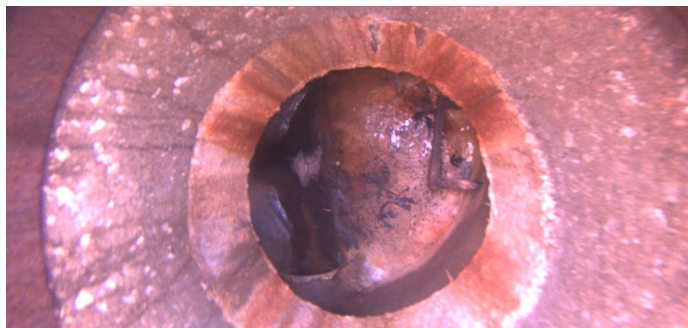
Code: **MGP**
Description: **General Photo**

Distance (ft): **.0**
Structural Grade: **0**
O&M Grade: **0**
Clock Start/From:
Clock To:
1st Value:
2nd Value:
Value Percent:
Step: **NO**
Remarks:

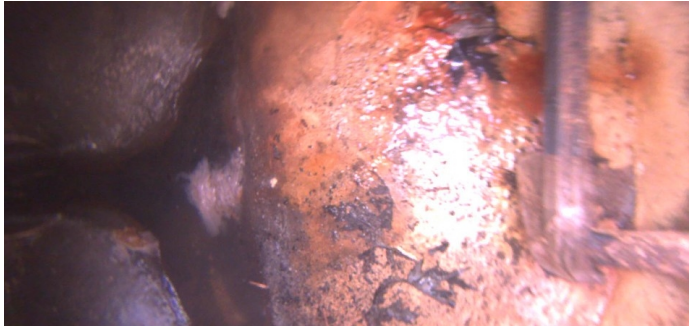
Code:	MGO
Description:	General Observation
Distance (ft):	2.1
Structural Grade:	0
O&M Grade:	0
Clock Start/From:	
Clock To:	
1st Value:	
2nd Value:	
Value Percent:	
Step:	NO
Remarks:	Ins. Comp.
