Manhole Inspection Report

Date:	03/20/2018	Weather:		Coding:	RZMACP
MH#:	M-903-005	Owner:	NA	Len. Surveyed:	4.9
P.O.#:		Surveyor:	John Kuglmaier	Rim to Invert:	6.0
Customer:		Cert. #:	U-1215-07002349	Wall Material:	Concrete (reinforced)

Street:	38th Ave. 136' West of Spencer Pl.	Project:	Hobart, IN
City:	Hobart, IN	GPS Northing:	2911405.034
Location:		GPS Easting:	2911405.034
Drain Area:	Northeast	GPS Accuracy:	Sub-Meter
Cover Shape:	Circular	Evidence of Surcharge:	No
Cover Size:	23.0	Potential for Runoff:	None
Comments:

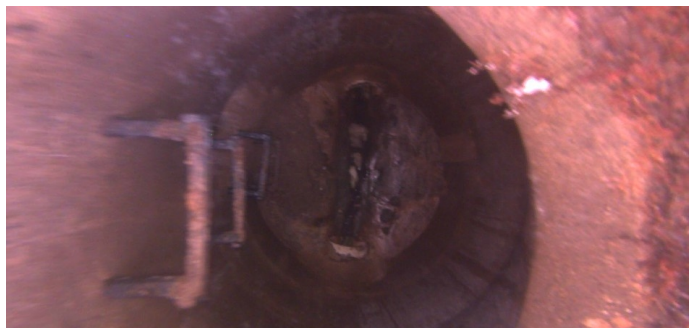
Code: **MGP**
Description: **General Photo**

Distance (ft): **.0**
Structural Grade: **0**
O&M Grade: **0**
Clock Start/From:
Clock To:
1st Value:
2nd Value:
Value Percent:
Step: **NO**
Remarks:

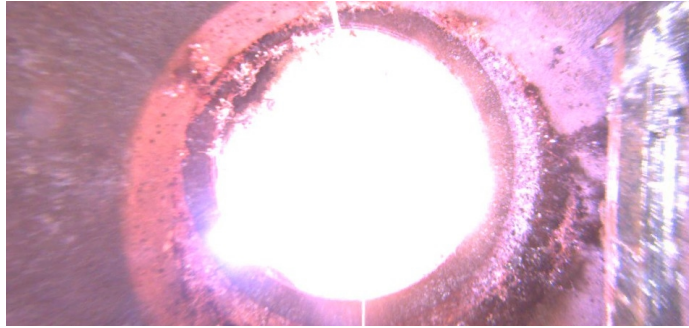
Code: **MGP**
Description: **General Photo**

Distance (ft): **2.3**
Structural Grade: **0**
O&M Grade: **0**
Clock Start/From:
Clock To:
1st Value:
2nd Value:
Value Percent:
Step: **NO**
Remarks:

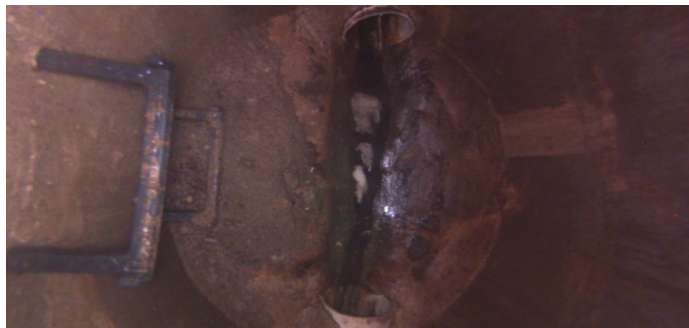
Code: **DSF**
Description: **Deposits Settled Fine**

Distance (ft): **2.8**
Structural Grade: **0**
O&M Grade: **2**
Clock Start/From: **6**
Clock To: **12**
1st Value:
2nd Value:
Value Percent: **10.000**
Step: **NO**
Remarks:

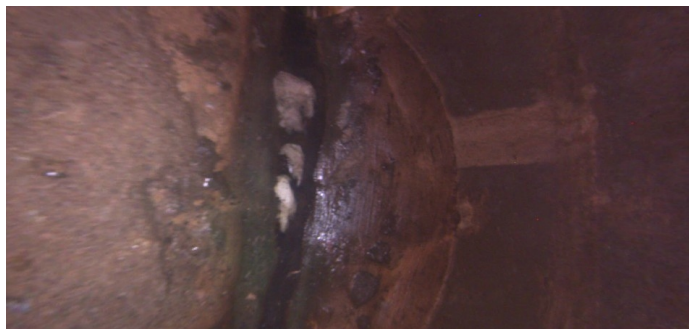
Code: **IS**
Description: **Infil Stain**

Distance (ft): **3.7**
Structural Grade: **0**
O&M Grade: **0**
Clock Start/From: **2**
Clock To:
1st Value:
2nd Value:
Value Percent:
Step: **NO**
Remarks:

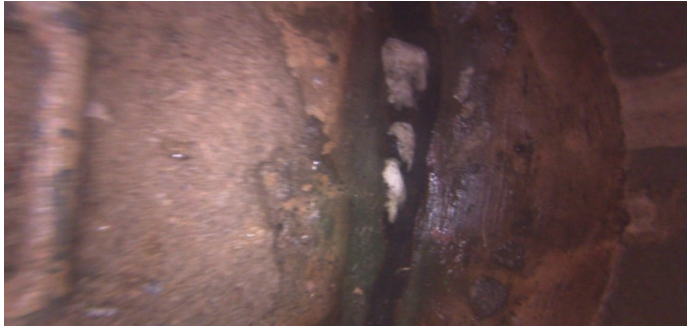
Code:	MGO
Description:	General Observation
Distance (ft):	4.2
Structural Grade:	0
O&M Grade:	0
Clock Start/From:	
Clock To:	
1st Value:	
2nd Value:	
Value Percent:	
Step:	NO
Remarks:	Ins. Comp.
