# Manhole Inspection Report

Date:	<b>03/20/2018</b>	Weather:		Coding:	<b>RZMACP</b>
MH#:	<b>M-903-006</b>	Owner:	<b>NA</b>	Len. Surveyed:	<b>6.6</b>
P.O.#:		Surveyor:	<b>John Kuglmaier</b>	Rim to Invert:	<b>8.0</b>
Customer:		Cert. #:	<b>U-1215-07002349</b>	Wall Material:	<b>Concrete (reinforced)</b>

Street:	<b>Intersection of Spencer Pl. and 38th</b>	Project:	<b>Hobart, IN</b>
City:	<b>Hobart, IN</b>	GPS Northing:	<b>0.0</b>
Location:		GPS Easting:	<b>0.0</b>
Drain Area:	<b>Northeast</b>	GPS Accuracy:	<b>Nearest Meter</b>
Cover Shape:	<b>Circular</b>	Evidence of Surcharge:	<b>No</b>
Cover Size:	<b>23.0</b>	Potential for Runoff:	<b>None</b>
Comments:

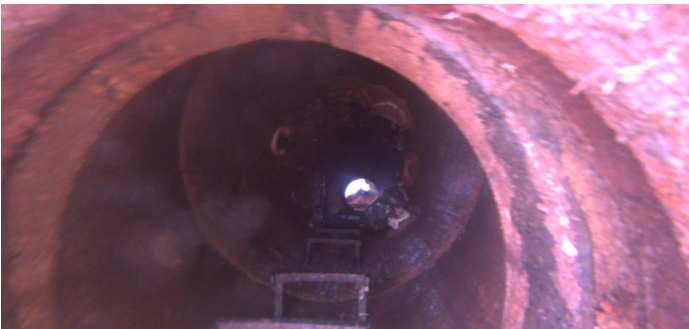
Code: **MGP**  
 Description: **General Photo**

Distance (ft): **.0**  
 Structural Grade: **0**  
 O&M Grade: **0**  
 Clock Start/From:  
 Clock To:  
 1st Value:  
 2nd Value:  
 Value Percent:  
 Step: **NO**  
 Remarks:

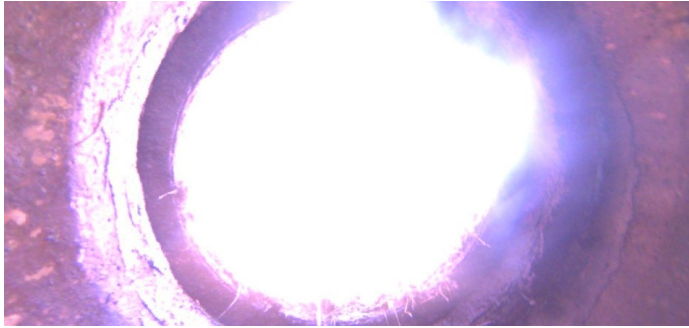
Code: **MGP**  
Description: **General Photo**

Distance (ft): **1.9**  
Structural Grade: **0**  
O&M Grade: **0**  
Clock Start/From:  
Clock To:  
1st Value:  
2nd Value:  
Value Percent:  
Step: **NO**  
Remarks:

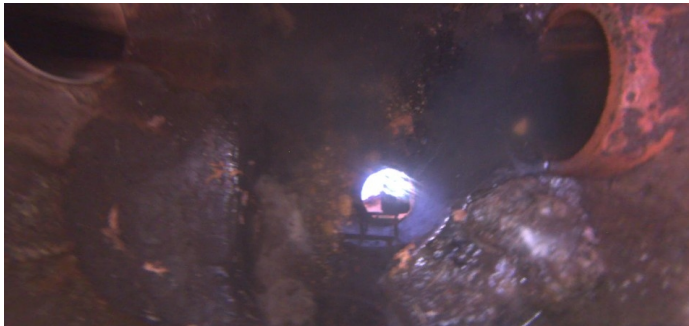
Code: **MGO**  
Description: **General Observation**

Distance (ft): **5.7**  
Structural Grade: **0**  
O&M Grade: **0**  
Clock Start/From:  
Clock To:  
1st Value:  
2nd Value:  
Value Percent:  
Step: **NO**  
Remarks: **Ins. Comp.**
