Manhole Inspection Report

Date:	03/20/2018	Weather:		Coding:	RZMACP
MH#:	M-903-007	Owner:	NA	Len. Surveyed:	6.8
P.O.#:		Surveyor:	John Kuglmaier	Rim to Invert:	8.0
Customer:		Cert. #:	U-1215-07002349	Wall Material:	Concrete (reinforced)

Street:	Intersection of Spencer Pl. and 38th	Project:	Hobart, IN
City:	Hobart, IN	GPS Northing:	2911582.506
Location:		GPS Easting:	2911582.506
Drain Area:	Northeast	GPS Accuracy:	Sub-Meter
Cover Shape:	Circular	Evidence of Surcharge:	No
Cover Size:	23.0	Potential for Runoff:	None
Comments:

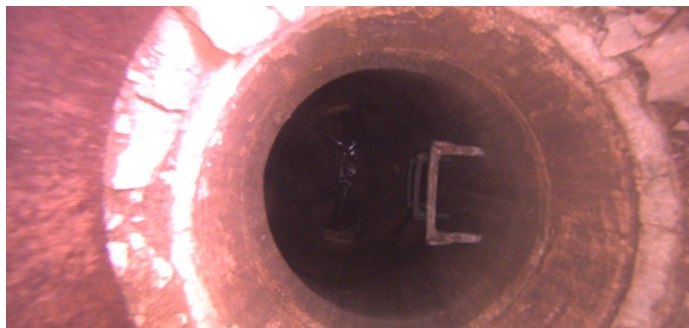
Code: **MGP**
Description: **General Photo**

Distance (ft): **.0**
Structural Grade: **0**
O&M Grade: **0**
Clock Start/From:
Clock To:
1st Value:
2nd Value:
Value Percent:
Step: **NO**
Remarks:

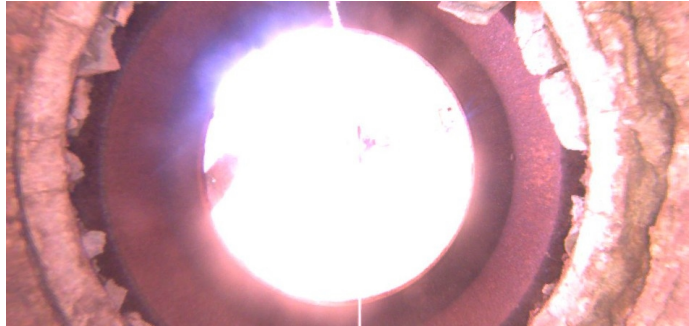
Code: **MGP**
Description: **General Photo**

Distance (ft): **2.1**
Structural Grade: **0**
O&M Grade: **0**
Clock Start/From:
Clock To:
1st Value:
2nd Value:
Value Percent:
Step: **NO**
Remarks:

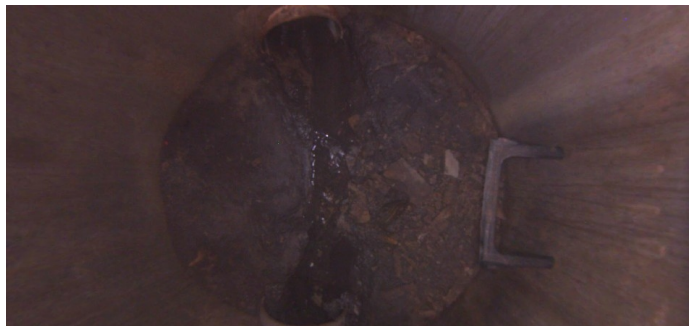
Code: **DAZ**
Description: **Deposits Attached Other**

Distance (ft): **4.6**
Structural Grade: **0**
O&M Grade: **2**
Clock Start/From: **12**
Clock To: **12**
1st Value:
2nd Value:
Value Percent: **10.000**
Step: **NO**
Remarks: **Mixed materials**

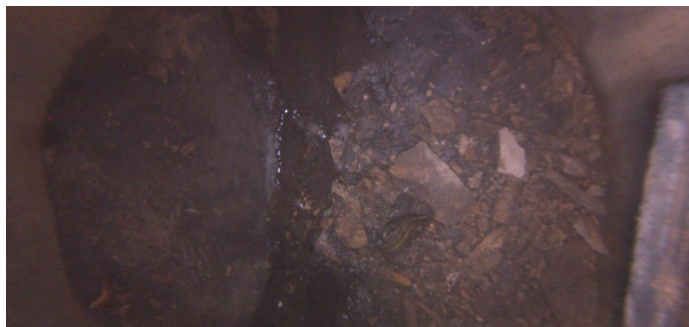
Code: **MGO**
Description: **General Observation**

Distance (ft): **5.7**
Structural Grade: **0**
O&M Grade: **0**
Clock Start/From:
Clock To:
1st Value:
2nd Value:
Value Percent:
Step: **NO**
Remarks: **Ins. Comp.**
