Manhole Inspection Report

Date:	03/20/2018	Weather:		Coding:	RZMACP
MH#:	M-903-009	Owner:	NA	Len. Surveyed:	4.6
P.O.#:		Surveyor:	John Kuglmaier	Rim to Invert:	5.6
Customer:		Cert. #:	U-1215-07002349	Wall Material:	Concrete (reinforced)

Street:	Spencer Pl. 43' South of 38th Pl.	Project:	Hobart, IN
City:	Hobart, IN	GPS Northing:	2911831.858
Location:		GPS Easting:	2911831.858
Drain Area:	Northeast	GPS Accuracy:	Sub-Meter
Cover Shape:	Circular	Evidence of Surcharge:	Yes
Cover Size:	23.0	Potential for Runoff:	None
Comments:

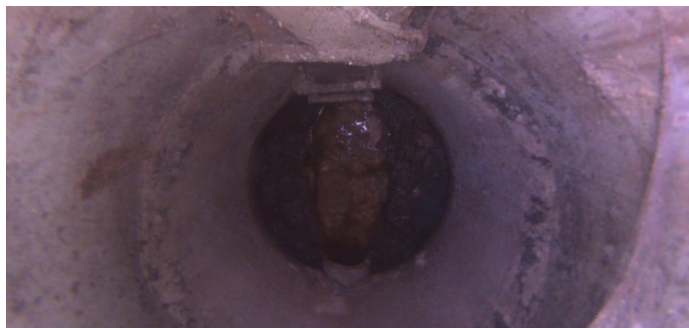
Code: **MGP**
Description: **General Photo**

Distance (ft): **.0**
Structural Grade: **0**
O&M Grade: **0**
Clock Start/From:
Clock To:
1st Value:
2nd Value:
Value Percent:
Step: **NO**
Remarks:

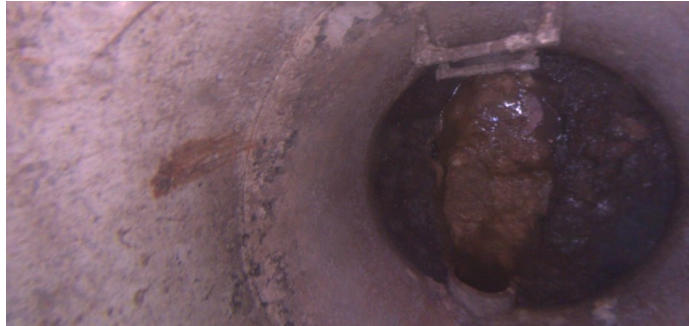
Code: **IS**
Description: **Infil Stain**

Distance (ft): **.9**
Structural Grade: **0**
O&M Grade: **0**
Clock Start/From: **9**
Clock To:
1st Value:
2nd Value:
Value Percent:
Step: **NO**
Remarks:

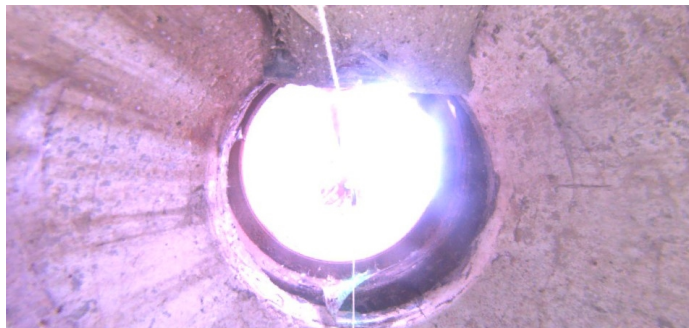
Code: **MGP**
Description: **General Photo**

Distance (ft): **2.1**
Structural Grade: **0**
O&M Grade: **0**
Clock Start/From:
Clock To:
1st Value:
2nd Value:
Value Percent:
Step: **NO**
Remarks:

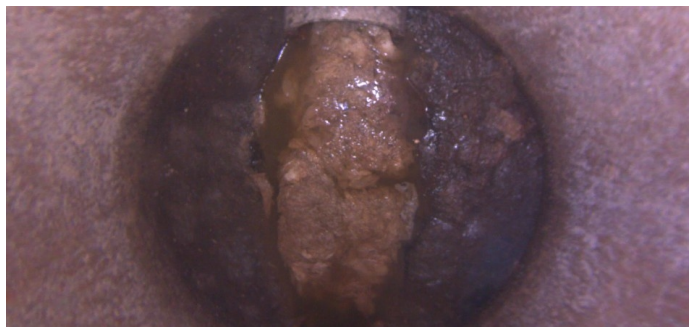
Code: **DAZ**
Description: **Deposits Attached Other**

Distance (ft): **2.9**
Structural Grade: **0**
O&M Grade: **2**
Clock Start/From: **12**
Clock To: **12**
1st Value:
2nd Value:
Value Percent: **10.000**
Step: **NO**
Remarks: **Mixed materials**

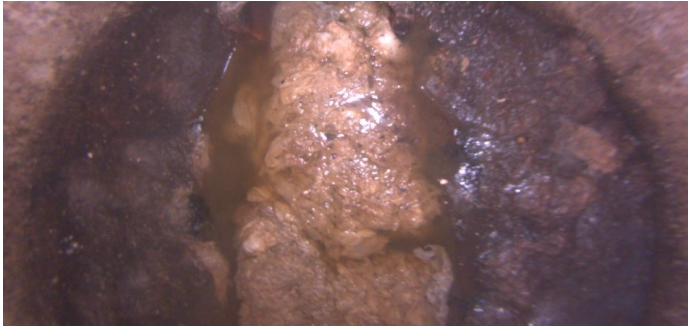
Code:	MGO
Description:	General Observation
Distance (ft):	3.8
Structural Grade:	0
O&M Grade:	0
Clock Start/From:	
Clock To:	
1st Value:	
2nd Value:	
Value Percent:	
Step:	NO
Remarks:	Ins. Comp.
