Manhole Inspection Report

Date:	03/20/2018	Weather:		Coding:	RZMACP
MH#:	M-903-011	Owner:	NA	Len. Surveyed:	4.4
P.O.#:		Surveyor:	John Kuglmaier	Rim to Invert:	5.6
Customer:		Cert. #:	U-1215-07002349	Wall Material:	Concrete (reinforced)

Street:	Spencer Pl. 43' South of 38th Pl.	Project:	Hobart, IN
City:	Hobart, IN	GPS Northing:	2911563.667
Location:		GPS Easting:	2911563.667
Drain Area:	Northeast	GPS Accuracy:	Sub-Meter
Cover Shape:	Circular	Evidence of Surcharge:	Yes
Cover Size:	23.0	Potential for Runoff:	None
Comments:

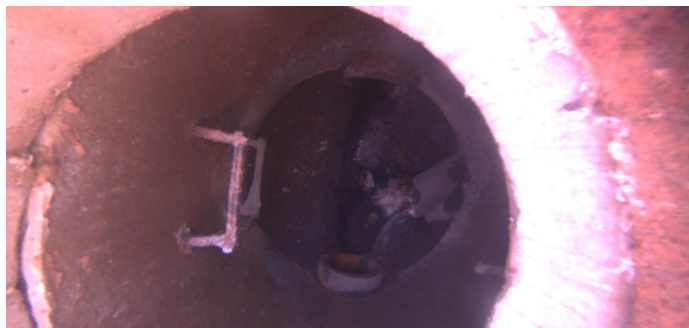
Code: **MGP**
Description: **General Photo**

Distance (ft): **.0**
Structural Grade: **0**
O&M Grade: **0**
Clock Start/From:
Clock To:
1st Value:
2nd Value:
Value Percent:
Step: **NO**
Remarks:

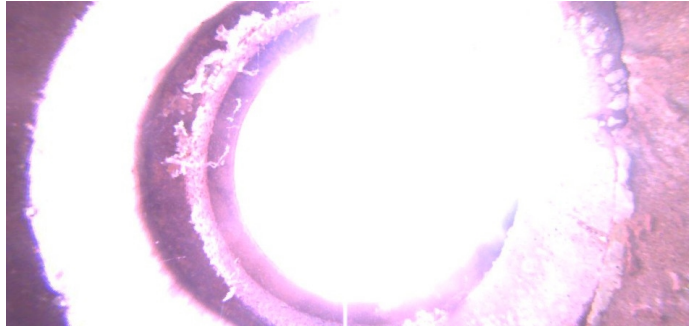
Code: **MGP**
Description: **General Photo**

Distance (ft): **2.2**
Structural Grade: **0**
O&M Grade: **0**
Clock Start/From:
Clock To:
1st Value:
2nd Value:
Value Percent:
Step: **NO**
Remarks:

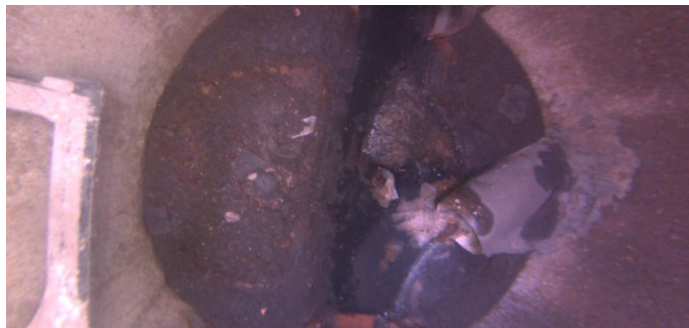
Code: **DAZ**
Description: **Deposits Attached Other**

Distance (ft): **2.6**
Structural Grade: **0**
O&M Grade: **3**
Clock Start/From: **12**
Clock To: **12**
1st Value:
2nd Value:
Value Percent: **15.000**
Step: **NO**
Remarks: **Mixed materials**

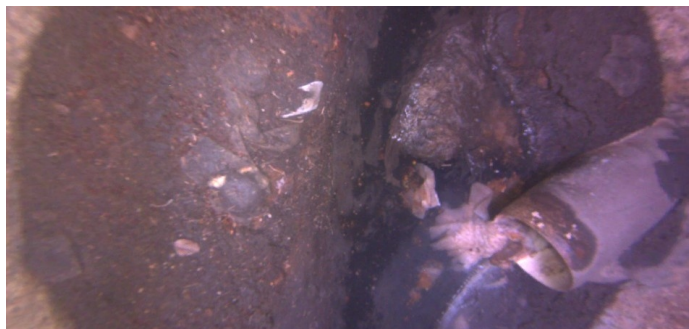
Code: **MGO**
Description: **General Observation**

Distance (ft): **3.6**
Structural Grade: **0**
O&M Grade: **0**
Clock Start/From:
Clock To:
1st Value:
2nd Value:
Value Percent:
Step: **NO**
Remarks: **Ins. Comp.**
