# Manhole Inspection Report

Date:	<b>03/28/2018</b>	Weather:		Coding:	<b>RZMACP</b>
MH#:	<b>M-903-012</b>	Owner:	<b>NA</b>	Len. Surveyed:	<b>2.7</b>
P.O.#:		Surveyor:	<b>John Kuglmaier</b>	Rim to Invert:	<b>4.0</b>
Customer:		Cert. #:	<b>U-1215-07002349</b>	Wall Material:	<b>Concrete (reinforced)</b>

Street:	<b>Intersection of Rand St. and Spencer</b>	Project:	<b>Hobart, IN</b>
City:	<b>Hobart, IN</b>	GPS Northing:	<b>0.0</b>
Location:		GPS Easting:	<b>0.0</b>
Drain Area:	<b>Northeast</b>	GPS Accuracy:	<b>Nearest Meter</b>
Cover Shape:	<b>Circular</b>	Evidence of Surcharge:	<b>No</b>
Cover Size:	<b>23.0</b>	Potential for Runoff:	<b>None</b>
Comments:

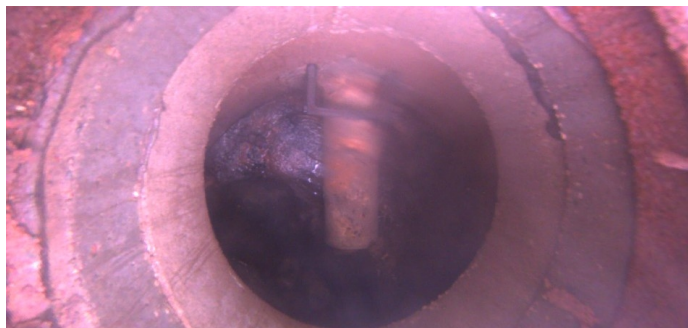
Code: **MGP**  
Description: **General Photo**

Distance (ft): **.0**  
Structural Grade: **0**  
O&M Grade: **0**  
Clock Start/From:  
Clock To:  
1st Value:  
2nd Value:  
Value Percent:  
Step: **NO**  
Remarks:

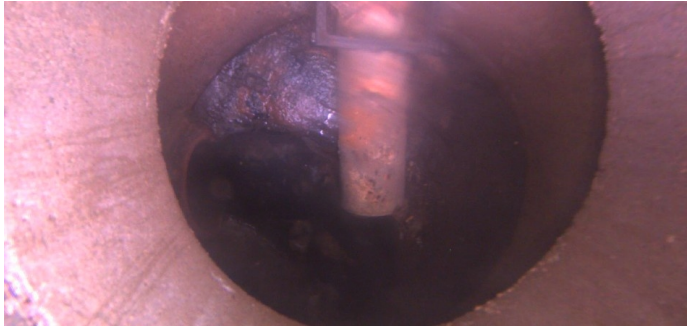
Code: **DSF**  
Description: **Deposits Settled Fine**

Distance (ft): **.7**  
Structural Grade: **0**  
O&M Grade: **2**  
Clock Start/From: **12**  
Clock To: **12**  
1st Value:  
2nd Value:  
Value Percent: **10.000**  
Step: **NO**  
Remarks:

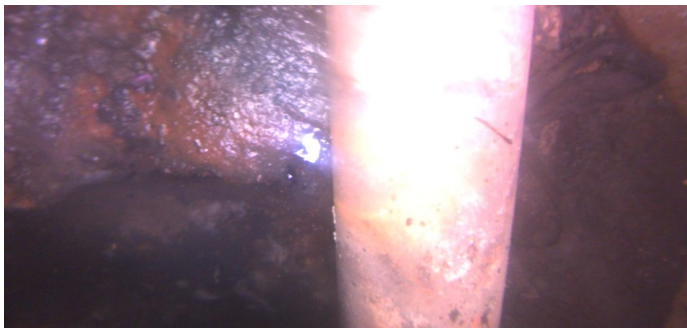
Code: **MGO**  
Description: **General Observation**

Distance (ft): **2.4**  
Structural Grade: **0**  
O&M Grade: **0**  
Clock Start/From:  
Clock To:  
1st Value:  
2nd Value:  
Value Percent:  
Step: **NO**  
Remarks: **Ins. Comp.**
