Manhole Inspection Report

Date:	03/28/2018	Weather:		Coding:	RZMACP
MH#:	M-903-018	Owner:	NA	Len. Surveyed:	4.8
P.O.#:		Surveyor:	John Kuglmaier	Rim to Invert:	6.2
Customer:		Cert. #:	U-1215-07002349	Wall Material:	Concrete (reinforced)

Street:	Rand St. 165' East of Brandt St.	Project:	Hobart, IN
City:	Hobart, IN	GPS Northing:	0.0
Location:		GPS Easting:	0.0
Drain Area:	Northeast	GPS Accuracy:	Nearest Meter
Cover Shape:	Circular	Evidence of Surcharge:	No
Cover Size:	23.0	Potential for Runoff:	None
Comments:

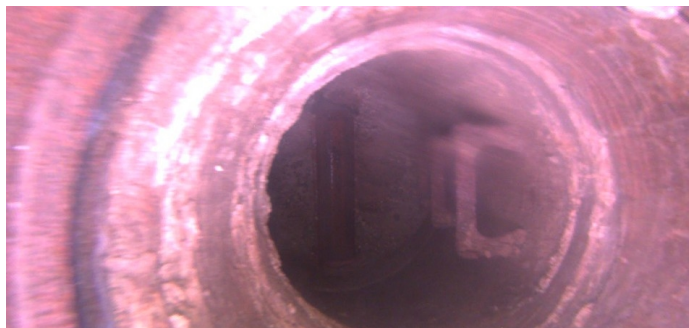
Code: **MGP**
Description: **General Photo**

Distance (ft): **.0**
Structural Grade: **0**
O&M Grade: **0**
Clock Start/From:
Clock To:
1st Value:
2nd Value:
Value Percent:
Step: **NO**
Remarks:

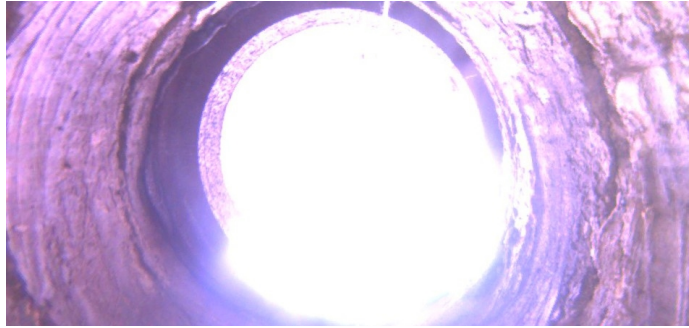
Code: **MGP**
Description: **General Photo**

Distance (ft): **2.2**
Structural Grade: **0**
O&M Grade: **0**
Clock Start/From:
Clock To:
1st Value:
2nd Value:
Value Percent:
Step: **NO**
Remarks:

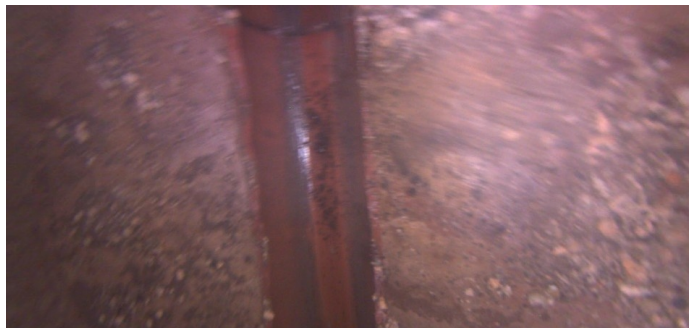
Code: **MGO**
Description: **General Observation**

Distance (ft): **4.1**
Structural Grade: **0**
O&M Grade: **0**
Clock Start/From:
Clock To:
1st Value:
2nd Value:
Value Percent:
Step: **NO**
Remarks: **Ins. Comp.**
