Manhole Inspection Report

Date:	03/28/2018	Weather:		Coding:	RZMACP
MH#:	M-903-021	Owner:	NA	Len. Surveyed:	8.1
P.O.#:		Surveyor:	John Kuglmaier	Rim to Invert:	10.8
Customer:		Cert. #:	U-1215-07002349	Wall Material:	Concrete (reinforced)

Street:	Rand St. 158' West of Brandt St.	Project:	Hobart, IN
City:	Hobart, IN	GPS Northing:	0.0
Location:		GPS Easting:	0.0
Drain Area:	Northeast	GPS Accuracy:	Nearest Meter
Cover Shape:	Circular	Evidence of Surcharge:	Yes
Cover Size:	23.0	Potential for Runoff:	None
Comments:

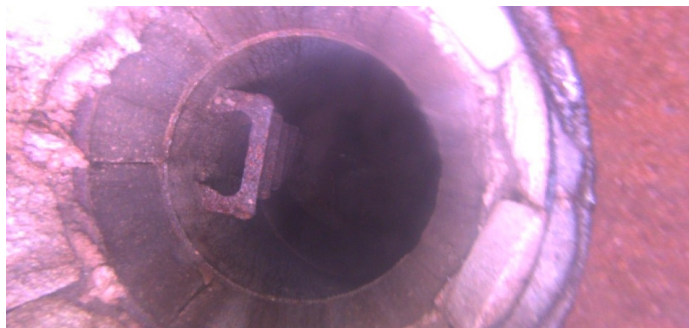
Code: **MGP**
Description: **General Photo**

Distance (ft): **.0**
Structural Grade: **0**
O&M Grade: **0**
Clock Start/From:
Clock To:
1st Value:
2nd Value:
Value Percent:
Step: **NO**
Remarks:

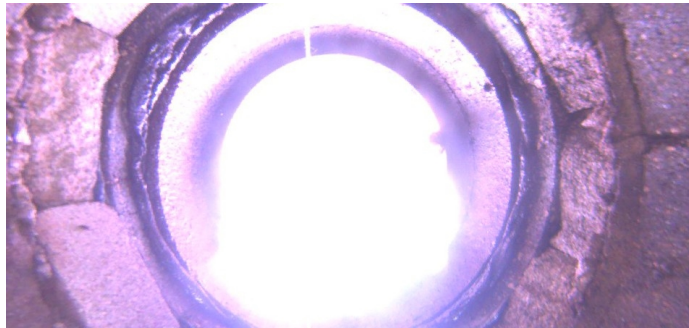
Code: **MGP**
Description: **General Photo**

Distance (ft): **2.2**
Structural Grade: **0**
O&M Grade: **0**
Clock Start/From:
Clock To:
1st Value:
2nd Value:
Value Percent:
Step: **NO**
Remarks:

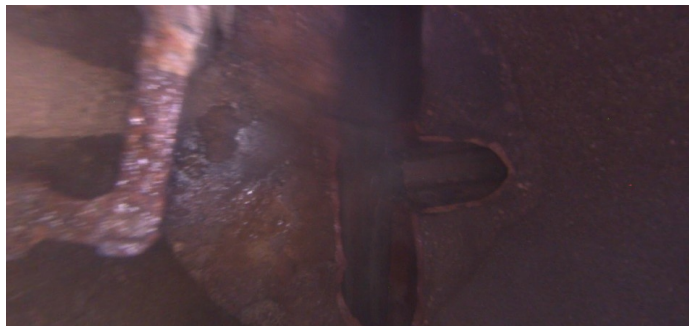
Code: **DAZ**
Description: **Deposits Attached Other**

Distance (ft): **6.1**
Structural Grade: **0**
O&M Grade: **2**
Clock Start/From: **12**
Clock To: **12**
1st Value:
2nd Value:
Value Percent: **5.000**
Step: **NO**
Remarks: **Mixed materials**

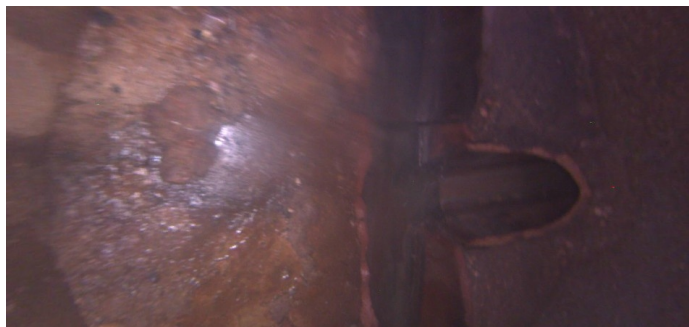
Code: **MGO**
Description: **General Observation**

Distance (ft): **7.2**
Structural Grade: **0**
O&M Grade: **0**
Clock Start/From:
Clock To:
1st Value:
2nd Value:
Value Percent:
Step: **NO**
Remarks: **Ins. Comp.**
