Manhole Inspection Report

Date:	03/28/2018	Weather:		Coding:	RZMACP
MH#:	M-903-024	Owner:	NA	Len. Surveyed:	8.6
P.O.#:		Surveyor:	John Kuglmaier	Rim to Invert:	10.3
Customer:		Cert. #:	U-1215-07002349	Wall Material:	Concrete (reinforced)

Street:	Intersection of Rush St. and Rand St.	Project:	Hobart, IN
City:	Hobart, IN	GPS Northing:	0.0
Location:		GPS Easting:	0.0
Drain Area:	Northeast	GPS Accuracy:	Nearest Meter
Cover Shape:	Circular	Evidence of Surcharge:	Yes
Cover Size:	23.0	Potential for Runoff:	None
Comments:

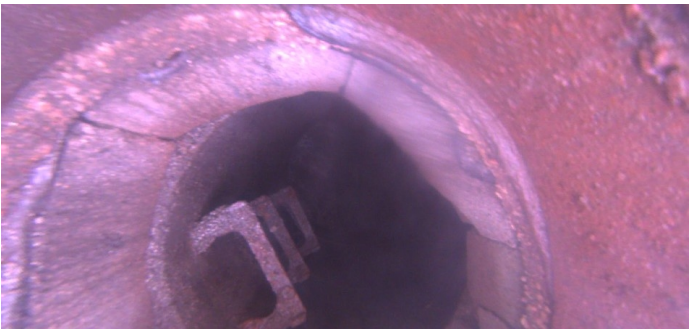
Code: **MGP**
Description: **General Photo**

Distance (ft): **.0**
Structural Grade: **0**
O&M Grade: **0**
Clock Start/From:
Clock To:
1st Value:
2nd Value:
Value Percent:
Step: **NO**
Remarks:

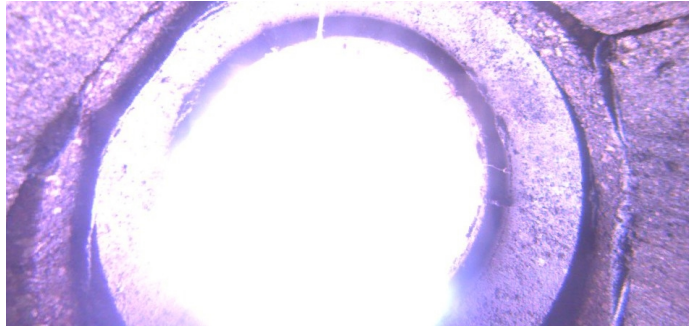
Code: **MGP**
Description: **General Photo**

Distance (ft): **2.0**
Structural Grade: **0**
O&M Grade: **0**
Clock Start/From:
Clock To:
1st Value:
2nd Value:
Value Percent:
Step: **NO**
Remarks:

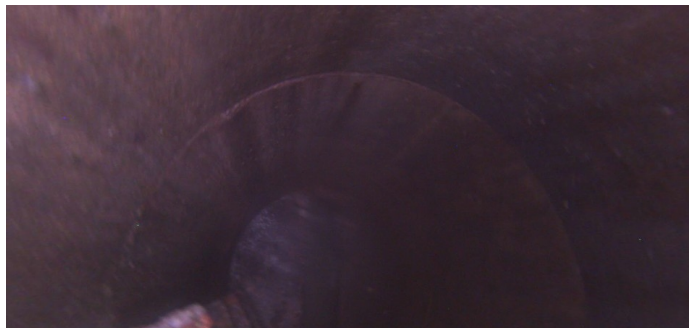
Code: **IS**
Description: **Infil Stain**

Distance (ft): **2.5**
Structural Grade: **0**
O&M Grade: **0**
Clock Start/From: **11**
Clock To: **12**
1st Value:
2nd Value:
Value Percent:
Step: **NO**
Remarks:

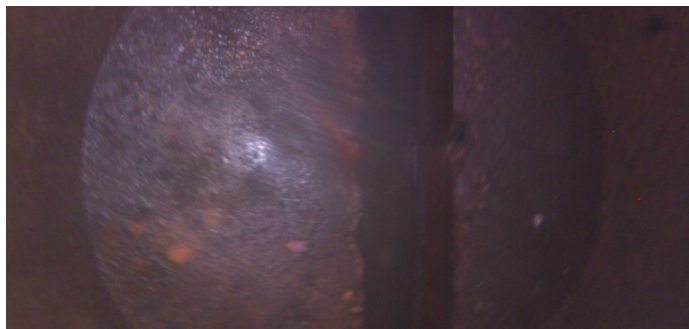
Code: **MGO**
Description: **General Observation**

Distance (ft): **7.4**
Structural Grade: **0**
O&M Grade: **0**
Clock Start/From:
Clock To:
1st Value:
2nd Value:
Value Percent:
Step: **NO**
Remarks: **Ins. Comp.**
