Manhole Inspection Report

Date:	03/28/2018	Weather:		Coding:	RZMACP
MH#:	M-903-026	Owner:	NA	Len. Surveyed:	8.9
P.O.#:		Surveyor:	John Kuglmaier	Rim to Invert:	10.4
Customer:		Cert. #:	U-1215-07002349	Wall Material:	Concrete (reinforced)

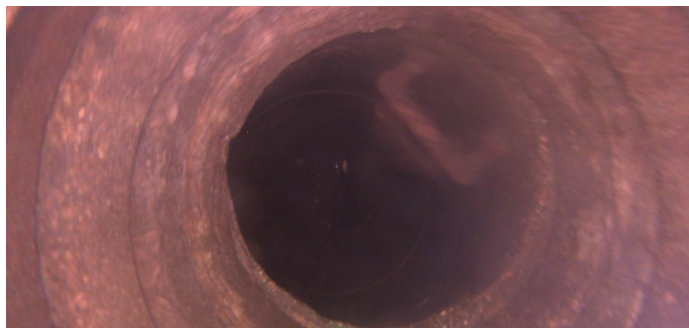
Code: **MGP**
 Description: **General Photo**

Distance (ft): **.0**
 Structural Grade: **0**
 O&M Grade: **0**
 Clock Start/From:
 Clock To:
 1st Value:
 2nd Value:
 Value Percent:
 Step: **NO**
 Remarks:

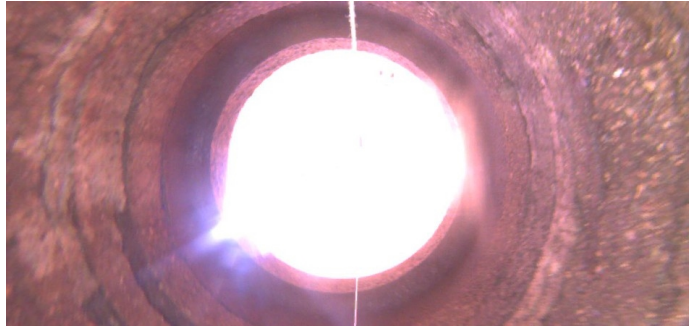
Code: **MGP**
Description: **General Photo**

Distance (ft): **2.5**
Structural Grade: **0**
O&M Grade: **0**
Clock Start/From:
Clock To:
1st Value:
2nd Value:
Value Percent:
Step: **NO**
Remarks:

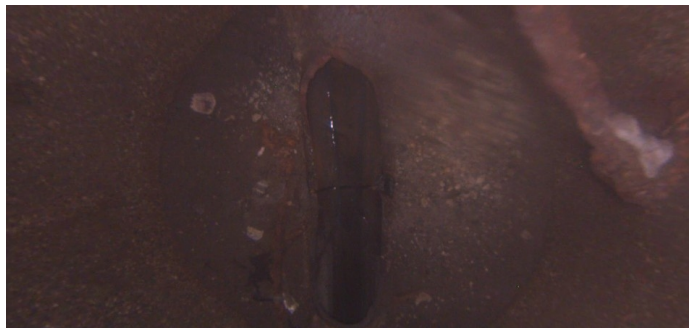
Code: **DAZ**
Description: **Deposits Attached Other**

Distance (ft): **6.9**
Structural Grade: **0**
O&M Grade: **2**
Clock Start/From: **12**
Clock To: **12**
1st Value:
2nd Value:
Value Percent: **10.000**
Step: **NO**
Remarks: **Mixed materials**

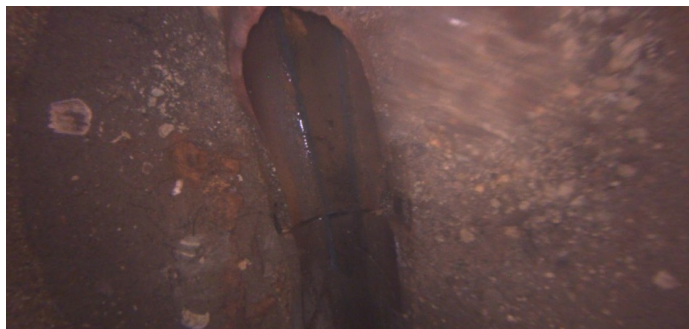
Code: **MGO**
Description: **General Observation**

Distance (ft): **8.1**
Structural Grade: **0**
O&M Grade: **0**
Clock Start/From:
Clock To:
1st Value:
2nd Value:
Value Percent:
Step: **NO**
Remarks: **Ins. Comp.**
