Manhole Inspection Report

Date:	03/28/2018	Weather:		Coding:	RZMACP
MH#:	M-903-028	Owner:	NA	Len. Surveyed:	9.5
P.O.#:		Surveyor:	John Kuglmaier	Rim to Invert:	11.3
Customer:		Cert. #:	U-1215-07002349	Wall Material:	Concrete (reinforced)

Street:	Intersection of Rand St. and Pershin	Project:	Hobart, IN
City:	Hobart, IN	GPS Northing:	0.0
Location:		GPS Easting:	0.0
Drain Area:	Northeast	GPS Accuracy:	Nearest Meter
Cover Shape:	Circular	Evidence of Surcharge:	Yes
Cover Size:	23.0	Potential for Runoff:	None
Comments:

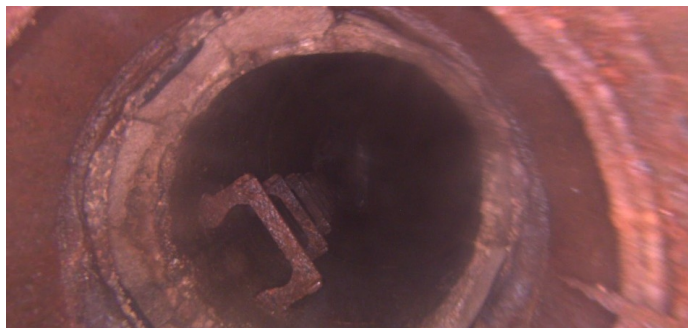
Code: **MGP**
Description: **General Photo**

Distance (ft): **.0**
Structural Grade: **0**
O&M Grade: **0**
Clock Start/From:
Clock To:
1st Value:
2nd Value:
Value Percent:
Step: **NO**
Remarks:

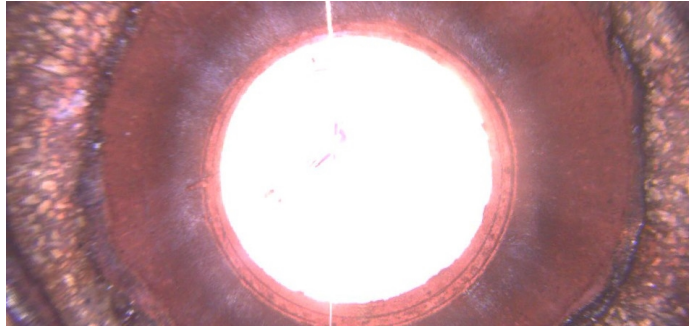
Code: **MGP**
Description: **General Photo**

Distance (ft): **2.2**
Structural Grade: **0**
O&M Grade: **0**
Clock Start/From:
Clock To:
1st Value:
2nd Value:
Value Percent:
Step: **NO**
Remarks:

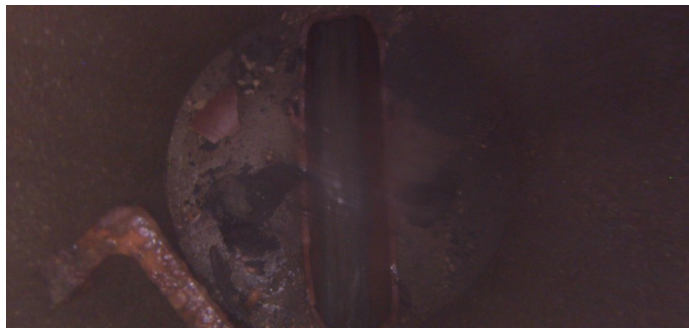
Code: **DAZ**
Description: **Deposits Attached Other**

Distance (ft): **7.2**
Structural Grade: **0**
O&M Grade: **2**
Clock Start/From: **12**
Clock To: **12**
1st Value:
2nd Value:
Value Percent: **5.000**
Step: **NO**
Remarks: **Mixed materials**

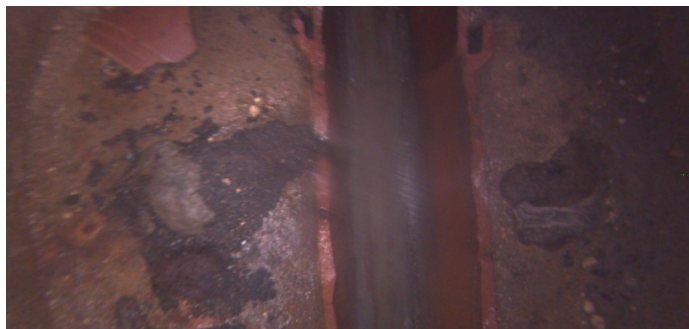
Code: **MGO**
Description: **General Observation**

Distance (ft): **8.8**
Structural Grade: **0**
O&M Grade: **0**
Clock Start/From:
Clock To:
1st Value:
2nd Value:
Value Percent:
Step: **NO**
Remarks: **Ins. Comp.**
