Manhole Inspection Report

Date:	04/12/2018	Weather:		Coding:	RZMACP
MH#:	M-903-033	Owner:	NA	Len. Surveyed:	10.0
P.O.#:		Surveyor:	John Kuglmaier	Rim to Invert:	11.6
Customer:		Cert. #:	U-1215-07002349	Wall Material:	Concrete (reinforced)

Street:	Wisconsin St. 29' North of 40th Plac	Project:	Hobart, IN
City:	Hobart, IN	GPS Northing:	2909717.473
Location:		GPS Easting:	2909717.473
Drain Area:	Northwest	GPS Accuracy:	Sub-Meter
Cover Shape:	Circular	Evidence of Surcharge:	Yes
Cover Size:	23.0	Potential for Runoff:	None
Comments:

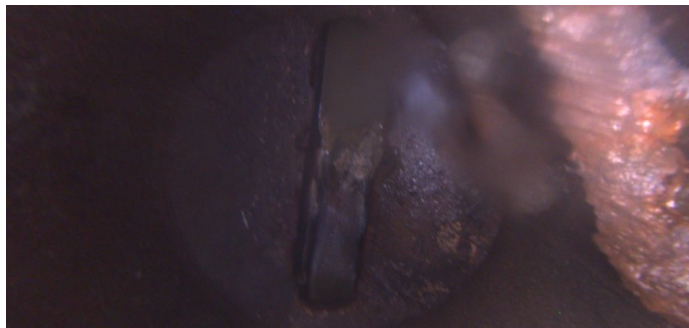
Code: **DSF**
Description: **Deposits Settled Fine**

Distance (ft): **7.6**
Structural Grade: **0**
O&M Grade: **2**
Clock Start/From: **12**
Clock To: **12**
1st Value:
2nd Value:
Value Percent: **10.000**
Step: **NO**
Remarks:

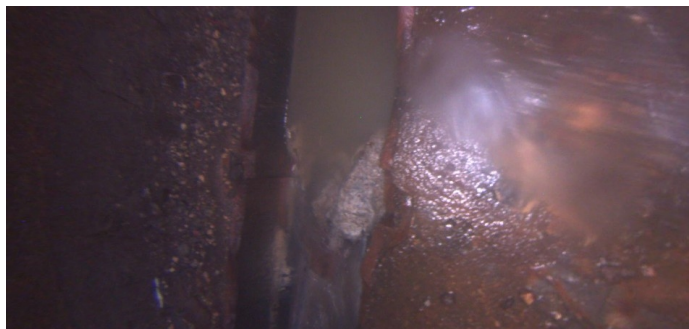
Code: **MGO**
Description: **General Observation**

Distance (ft): **9.4**
Structural Grade: **0**
O&M Grade: **0**
Clock Start/From:
Clock To:
1st Value:
2nd Value:
Value Percent:
Step: **NO**
Remarks: **Ins. Comp.**
