# Manhole Inspection Report

Date:	<b>03/21/2018</b>	Weather:		Coding:	<b>RZMACP</b>
MH#:	<b>M-903-035</b>	Owner:	<b>NA</b>	Len. Surveyed:	<b>7.6</b>
P.O.#:		Surveyor:	<b>John Kuglmaier</b>	Rim to Invert:	<b>9.0</b>
Customer:		Cert. #:	<b>U-1215-07002349</b>	Wall Material:	<b>Concrete (reinforced)</b>

Street:	<b>238' East of Hwy 51. 211' North of 3</b>	Project:	<b>Hobart, IN</b>
City:	<b>Hobart, IN</b>	GPS Northing:	<b>0.0</b>
Location:		GPS Easting:	<b>0.0</b>
Drain Area:	<b>Northeast</b>	GPS Accuracy:	<b>Nearest Meter</b>
Cover Shape:	<b>Circular</b>	Evidence of Surcharge:	<b>Yes</b>
Cover Size:	<b>23.0</b>	Potential for Runoff:	<b>None</b>
Comments:

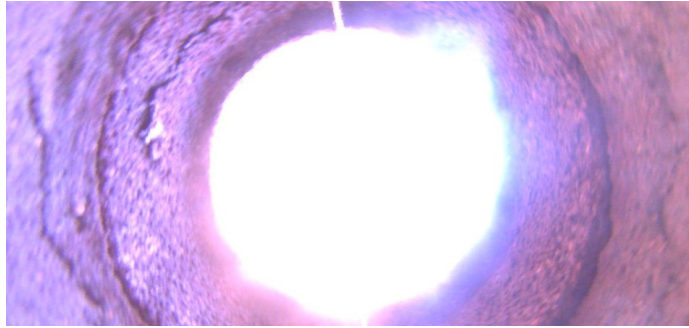
Code: **MGP**  
Description: **General Photo**

Distance (ft): **2.0**  
Structural Grade: **0**  
O&M Grade: **0**  
Clock Start/From:  
Clock To:  
1st Value:  
2nd Value:  
Value Percent:  
Step: **NO**  
Remarks:

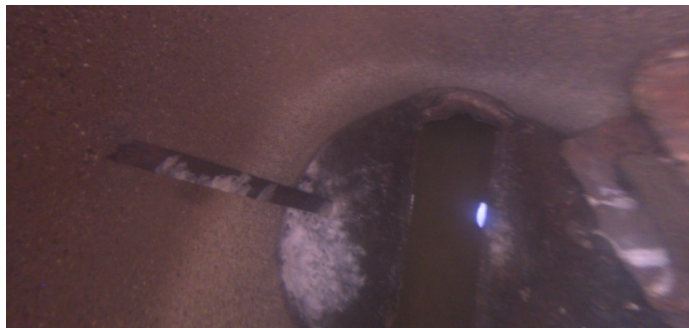
Code: **OBZ**  
Description: **Obstacle Other**

Distance (ft): **4.5**  
Structural Grade: **0**  
O&M Grade: **2**  
Clock Start/From: **10**  
Clock To:  
1st Value:  
2nd Value:  
Value Percent: **5.000**  
Step: **NO**  
Remarks: **Wood**

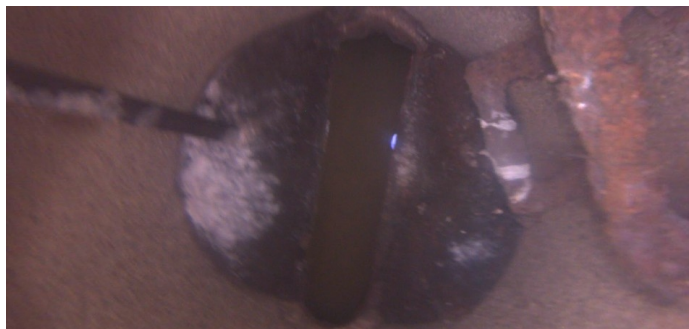
Code: **DSF**  
Description: **Deposits Settled Fine**

Distance (ft): **4.9**  
Structural Grade: **0**  
O&M Grade: **2**  
Clock Start/From: **12**  
Clock To: **12**  
1st Value:  
2nd Value:  
Value Percent: **10.000**  
Step: **NO**  
Remarks:

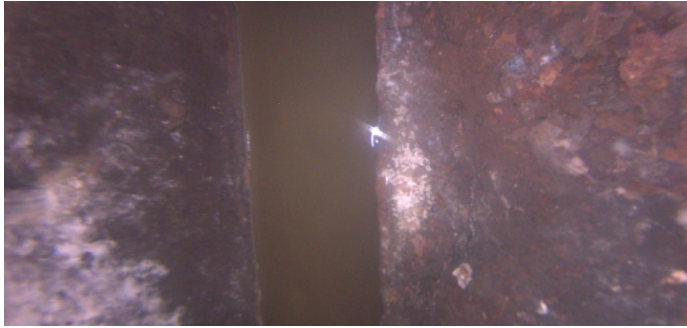
Code:	<b>MGO</b>
Description:	<b>General Observation</b>
Distance (ft):	<b>6.6</b>
Structural Grade:	<b>0</b>
O&M Grade:	<b>0</b>
Clock Start/From:	
Clock To:	
1st Value:	
2nd Value:	
Value Percent:	
Step:	<b>NO</b>
Remarks:	<b>Ins. Comp.</b>
