Manhole Inspection Report

Date:	03/21/2018	Weather:		Coding:	RZMACP
MH#:	M-903-040	Owner:	NA	Len. Surveyed:	5.3
P.O.#:		Surveyor:	John Kuglmaier	Rim to Invert:	6.6
Customer:		Cert. #:	U-1215-07002349	Wall Material:	Concrete (reinforced)

Street:	694' East of Hwy 51. and 195' North	Project:	Hobart, IN
City:	Hobart, IN	GPS Northing:	0.0
Location:		GPS Easting:	0.0
Drain Area:	Northeast	GPS Accuracy:	Nearest Meter
Cover Shape:	Circular	Evidence of Surcharge:	No
Cover Size:	23.0	Potential for Runoff:	None
Comments:

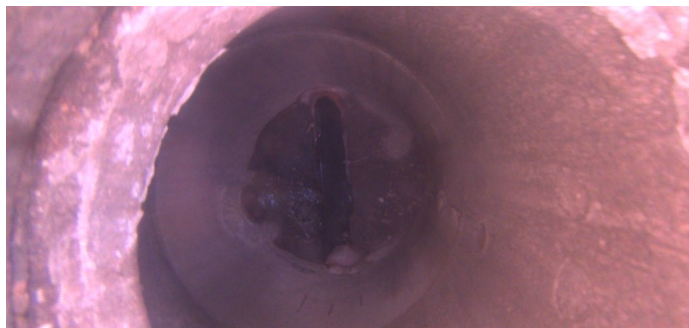
Code: **MGP**
Description: **General Photo**

Distance (ft): **.0**
Structural Grade: **0**
O&M Grade: **0**
Clock Start/From:
Clock To:
1st Value:
2nd Value:
Value Percent:
Step: **NO**
Remarks:

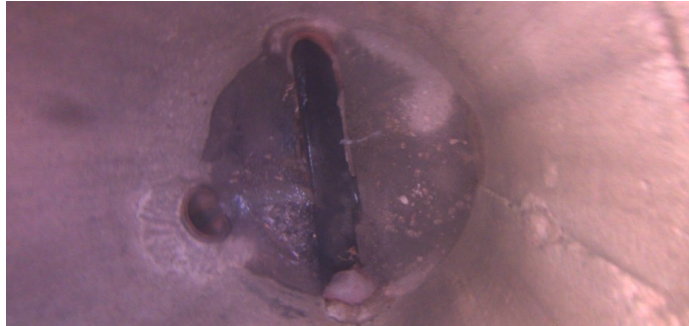
Code:	DSF
Description:	Deposits Settled Fine
Distance (ft):	2.4
Structural Grade:	0
O&M Grade:	2
Clock Start/From:	12
Clock To:	12
1st Value:	
2nd Value:	
Value Percent:	5.000
Step:	NO
Remarks:

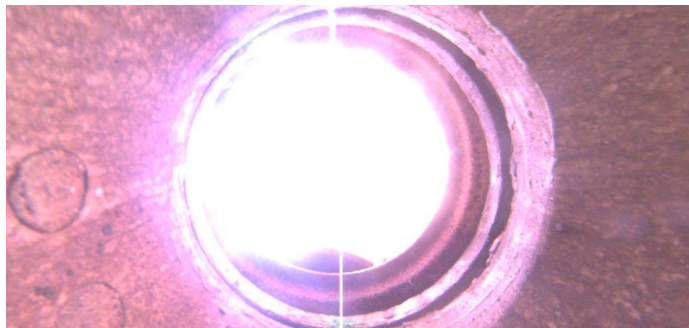
Code:	MGP
Description:	General Photo
Distance (ft):	2.4
Structural Grade:	0
O&M Grade:	0
Clock Start/From:	
Clock To:	
1st Value:	
2nd Value:	
Value Percent:	
Step:	NO
Remarks:

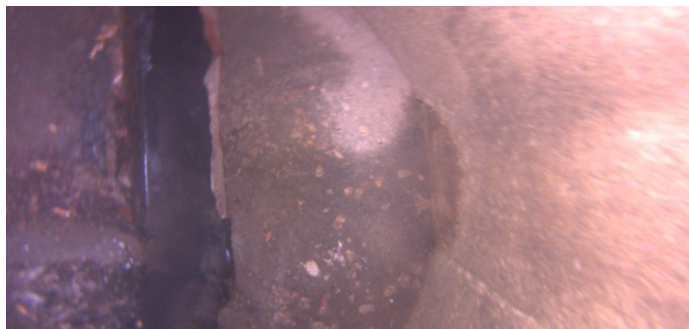
Code:	IS
Description:	Infil Stain
Distance (ft):	4.0
Structural Grade:	0
O&M Grade:	0
Clock Start/From:	2
Clock To:	4
1st Value:	
2nd Value:	
Value Percent:	
Step:	NO
Remarks:

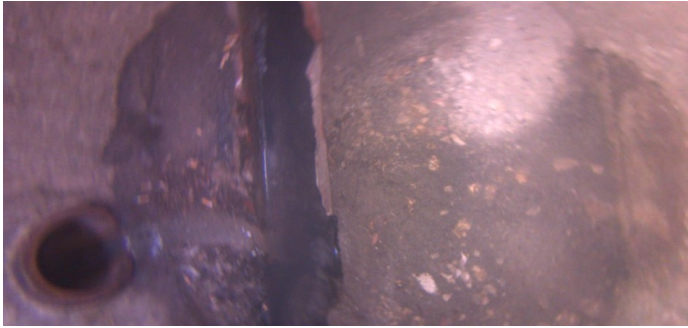
Code:	MGO
Description:	General Observation
Distance (ft):	4.3
Structural Grade:	0
O&M Grade:	0
Clock Start/From:	
Clock To:	
1st Value:	
2nd Value:	
Value Percent:	
Step:	NO
Remarks:	Ins. Comp.
