Manhole Inspection Report

Date:	03/20/2018	Weather:		Coding:	RZMACP
MH#:	M-903-041	Owner:	NA	Len. Surveyed:	5.3
P.O.#:		Surveyor:	John Kuglmaier	Rim to Invert:	6.4
Customer:		Cert. #:	U-1215-07002349	Wall Material:	Concrete (reinforced)

Street:	38th Pl. 696' East of Hwy 51.	Project:	Hobart, IN
City:	Hobart, IN	GPS Northing:	2910387.49
Location:		GPS Easting:	2910387.49
Drain Area:	Northeast	GPS Accuracy:	Sub-Meter
Cover Shape:	Circular	Evidence of Surcharge:	No
Cover Size:	23.0	Potential for Runoff:	None
Comments:

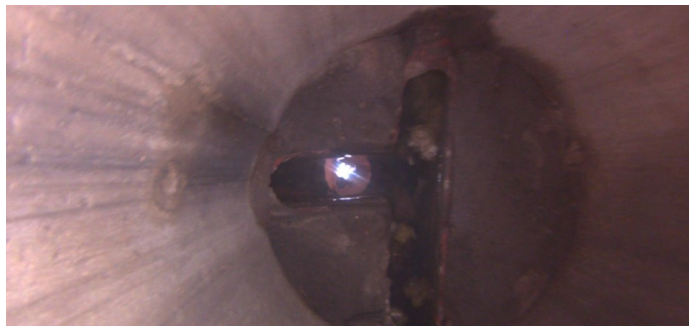
Code: **IS**
Description: **Infil Stain**

Distance (ft): **2.6**
Structural Grade: **0**
O&M Grade: **0**
Clock Start/From: **9**
Clock To: **10**
1st Value:
2nd Value:
Value Percent:
Step: **NO**
Remarks:

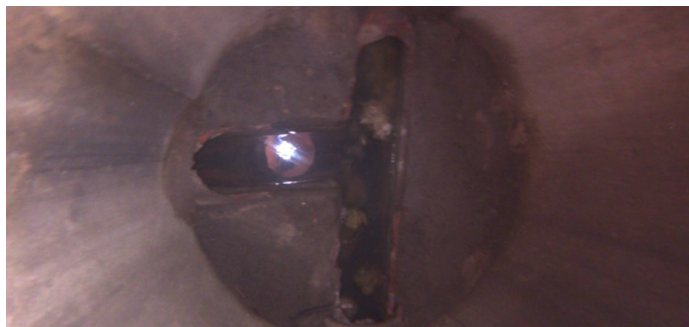
Code: **DSF**
Description: **Deposits Settled Fine**

Distance (ft): **3.1**
Structural Grade: **0**
O&M Grade: **2**
Clock Start/From: **12**
Clock To: **12**
1st Value:
2nd Value:
Value Percent: **10.000**
Step: **NO**
Remarks:

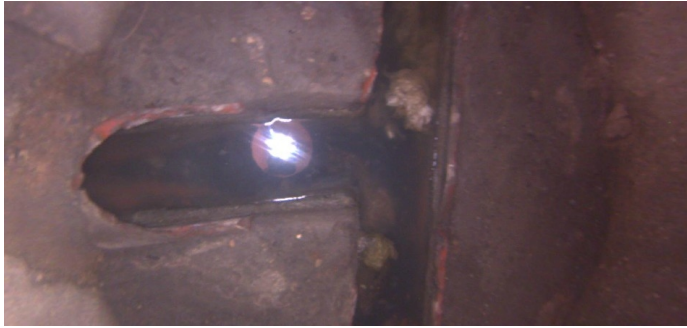
Code:	MGO
Description:	General Observation
Distance (ft):	4.2
Structural Grade:	0
O&M Grade:	0
Clock Start/From:	
Clock To:	
1st Value:	
2nd Value:	
Value Percent:	
Step:	NO
Remarks:	Ins. Comp.
