Manhole Inspection Report

Date:	03/20/2018	Weather:		Coding:	RZMACP
MH#:	M-903-042	Owner:	NA	Len. Surveyed:	4.6
P.O.#:		Surveyor:	John Kuglmaier	Rim to Invert:	5.8
Customer:		Cert. #:	U-1215-07002349	Wall Material:	Concrete (reinforced)

Street:	38th Pl. 547' West of Shelby Pl.	Project:	Hobart, IN
City:	Hobart, IN	GPS Northing:	2910661.237
Location:		GPS Easting:	2910661.237
Drain Area:	Northeast	GPS Accuracy:	Sub-Meter
Cover Shape:	Circular	Evidence of Surcharge:	No
Cover Size:	23.0	Potential for Runoff:	None
Comments:

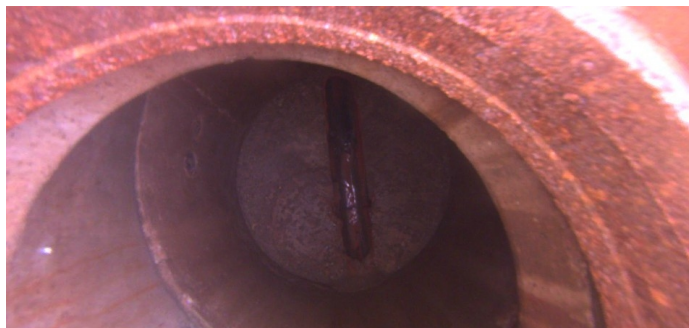
Code: **MGP**
Description: **General Photo**

Distance (ft): **.0**
Structural Grade: **0**
O&M Grade: **0**
Clock Start/From:
Clock To:
1st Value:
2nd Value:
Value Percent:
Step: **NO**
Remarks:

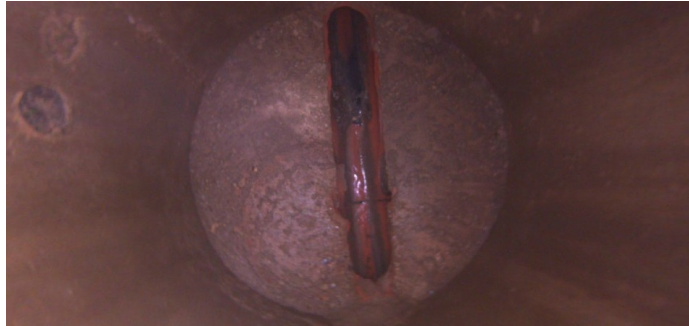
Code: **DSF**
Description: **Deposits Settled Fine**

Distance (ft): **1.7**
Structural Grade: **0**
O&M Grade: **2**
Clock Start/From: **12**
Clock To: **12**
1st Value:
2nd Value:
Value Percent: **5.000**
Step: **NO**
Remarks:

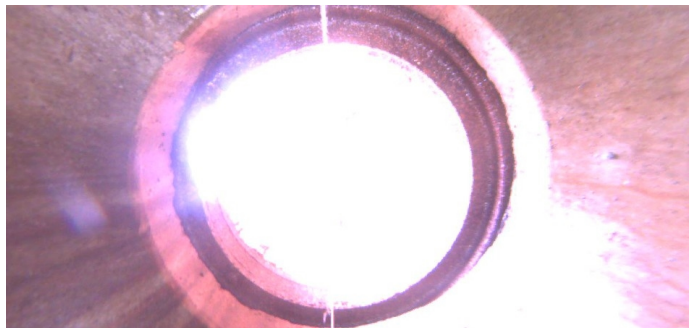
Code: **MGP**
Description: **General Photo**

Distance (ft): **2.6**
Structural Grade: **0**
O&M Grade: **0**
Clock Start/From:
Clock To:
1st Value:
2nd Value:
Value Percent:
Step: **NO**
Remarks:

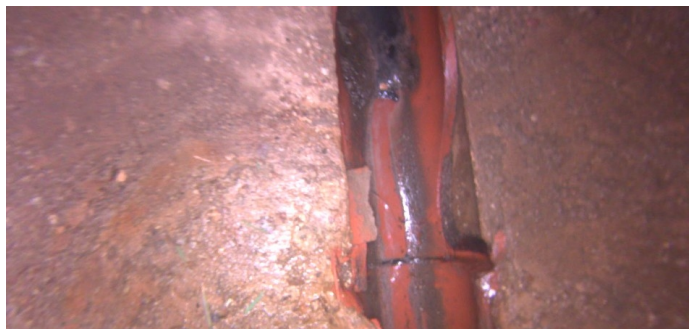
Code: **MGO**
Description: **General Observation**

Distance (ft): **3.8**
Structural Grade: **0**
O&M Grade: **0**
Clock Start/From:
Clock To:
1st Value:
2nd Value:
Value Percent:
Step: **NO**
Remarks: **Ins. Comp.**
