Manhole Inspection Report

Date:	03/20/2018	Weather:		Coding:	RZMACP
MH#:	M-903-043	Owner:	NA	Len. Surveyed:	3.8
P.O.#:		Surveyor:	John Kuglmaier	Rim to Invert:	4.9
Customer:		Cert. #:	U-1215-07002349	Wall Material:	Concrete (reinforced)

Street:	38th Pl. 256' West of Shelby Pl.	Project:	Hobart, IN
City:	Hobart, IN	GPS Northing:	2910949.448
Location:		GPS Easting:	2910949.448
Drain Area:	Northeast	GPS Accuracy:	Sub-Meter
Cover Shape:	Circular	Evidence of Surcharge:	No
Cover Size:	23.0	Potential for Runoff:	None
Comments:

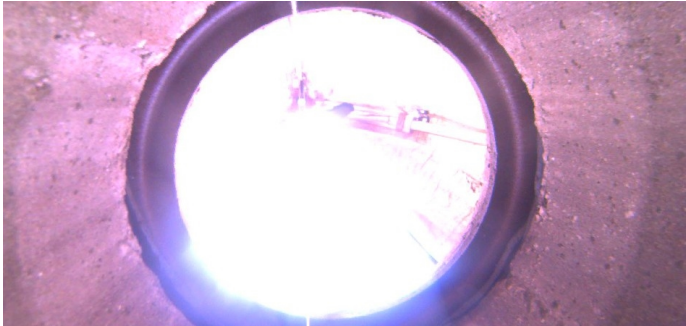
Code:	MGP
Description:	General Photo

Distance (ft):	1.8
Structural Grade:	0
O&M Grade:	0
Clock Start/From:	
Clock To:	
1st Value:	
2nd Value:	
Value Percent:	
Step:	NO
Remarks:

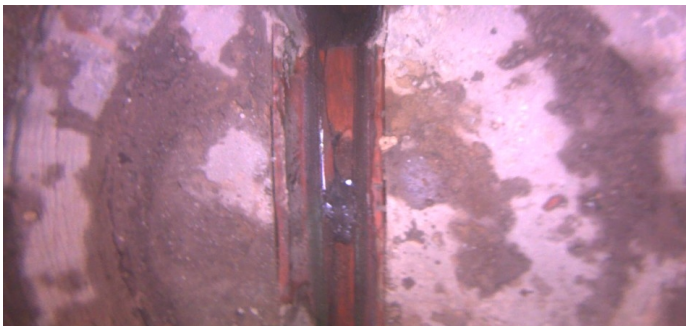
Code:	MGO
Description:	General Observation

Distance (ft):	2.7
Structural Grade:	0
O&M Grade:	0
Clock Start/From:	
Clock To:	
1st Value:	
2nd Value:	
Value Percent:	
Step:	NO
Remarks:	Ins. Comp.
