Manhole Inspection Report

Date:	03/28/2018	Weather:		Coding:	RZMACP
MH#:	M-903-044	Owner:	NA	Len. Surveyed:	4.3
P.O.#:		Surveyor:	John Kuglmaier	Rim to Invert:	5.7
Customer:		Cert. #:	U-1215-07002349	Wall Material:	Concrete (reinforced)

Street:	Southwest of Pershing St. 295' East	Project:	Hobart, IN
City:	Hobart, IN	GPS Northing:	0.0
Location:		GPS Easting:	0.0
Drain Area:	Northeast	GPS Accuracy:	Nearest Meter
Cover Shape:	Circular	Evidence of Surcharge:	No
Cover Size:	23.0	Potential for Runoff:	None
Comments:

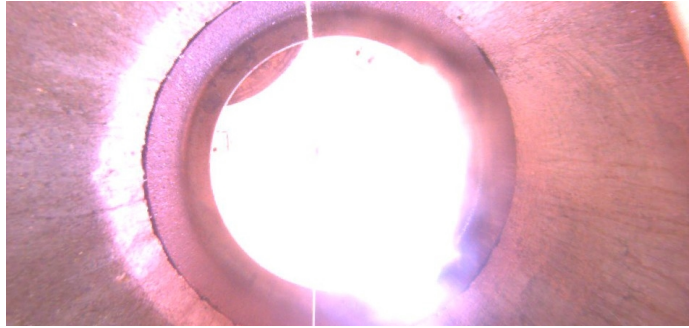
Code: **MGP**
Description: **General Photo**

Distance (ft): **2.0**
Structural Grade: **0**
O&M Grade: **0**
Clock Start/From:
Clock To:
1st Value:
2nd Value:
Value Percent:
Step: **NO**
Remarks:

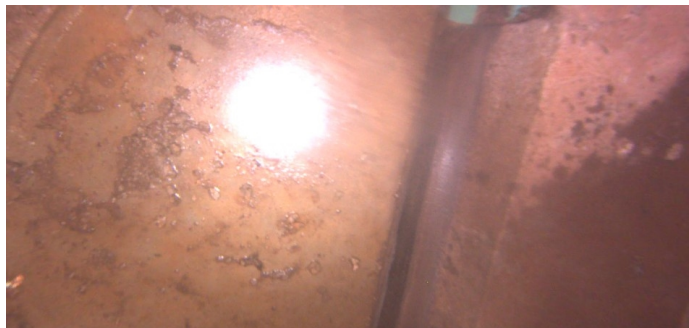
Code: **MGO**
Description: **General Observation**

Distance (ft): **3.7**
Structural Grade: **0**
O&M Grade: **0**
Clock Start/From:
Clock To:
1st Value:
2nd Value:
Value Percent:
Step: **NO**
Remarks: **Ins. Comp.**
