Manhole Inspection Report

Date:	03/28/2018	Weather:		Coding:	RZMACP
MH#:	M-903-046	Owner:	NA	Len. Surveyed:	5.6
P.O.#:		Surveyor:	John Kuglmaier	Rim to Invert:	7.0
Customer:		Cert. #:	U-1215-07002349	Wall Material:	Concrete (reinforced)

Street:	Southeast of Rush St. 598' South of	Project:	Hobart, IN
City:	Hobart, IN	GPS Northing:	0.0
Location:		GPS Easting:	0.0
Drain Area:	Northeast	GPS Accuracy:	Nearest Meter
Cover Shape:	Circular	Evidence of Surcharge:	No
Cover Size:	23.0	Potential for Runoff:	None
Comments:

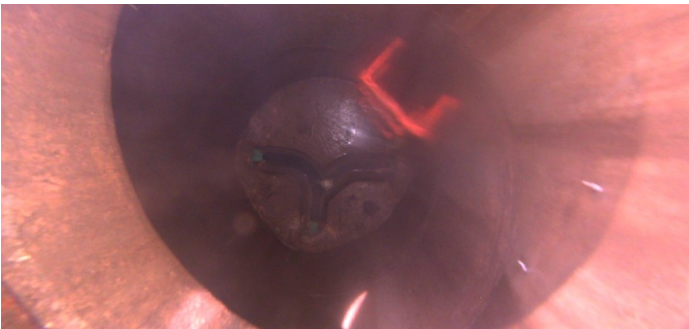
Code: **MGP**
Description: **General Photo**

Distance (ft): **.0**
Structural Grade: **0**
O&M Grade: **0**
Clock Start/From:
Clock To:
1st Value:
2nd Value:
Value Percent:
Step: **NO**
Remarks:

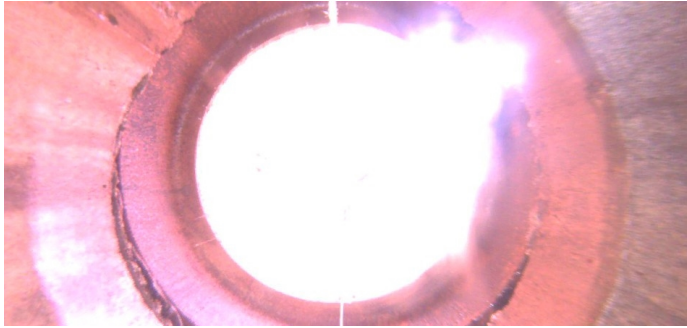
Code:	MGP
Description:	General Photo
Distance (ft):	2.0
Structural Grade:	0
O&M Grade:	0
Clock Start/From:	
Clock To:	
1st Value:	
2nd Value:	
Value Percent:	
Step:	NO
Remarks:

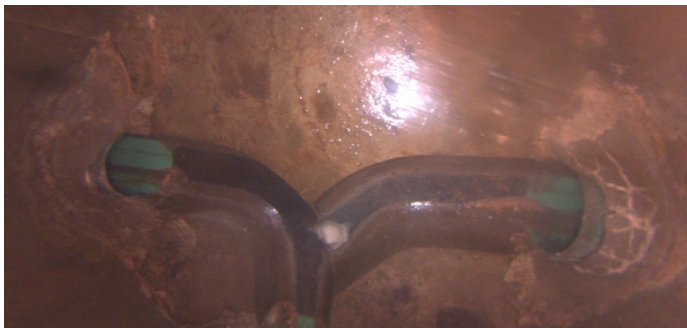
Code:	MGO
Description:	General Observation
Distance (ft):	4.5
Structural Grade:	0
O&M Grade:	0
Clock Start/From:	
Clock To:	
1st Value:	
2nd Value:	
Value Percent:	
Step:	NO
Remarks:	Ins. Comp.
