Manhole Inspection Report

Date:	03/28/2018	Weather:		Coding:	RZMACP
MH#:	M-903-049	Owner:	NA	Len. Surveyed:	4.1
P.O.#:		Surveyor:	John Kuglmaier	Rim to Invert:	5.1
Customer:		Cert. #:	U-1215-07002349	Wall Material:	Concrete (reinforced)

Street:	The East Side of Brandt St. 601' Sout	Project:	Hobart, IN
City:	Hobart, IN	GPS Northing:	0.0
Location:		GPS Easting:	0.0
Drain Area:	Northeast	GPS Accuracy:	Nearest Meter
Cover Shape:	Circular	Evidence of Surcharge:	No
Cover Size:	23.0	Potential for Runoff:	None
Comments:

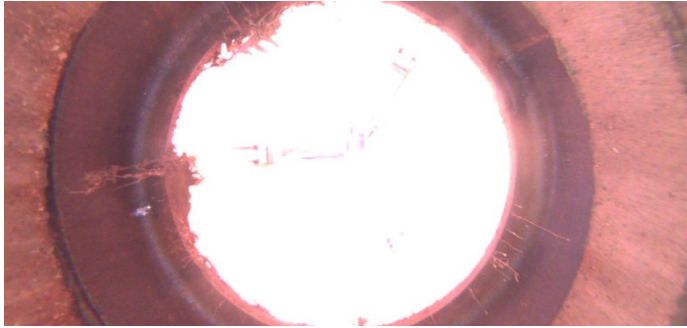
Code: **MGP**
Description: **General Photo**

Distance (ft): **1.8**
Structural Grade: **0**
O&M Grade: **0**
Clock Start/From:
Clock To:
1st Value:
2nd Value:
Value Percent:
Step: **NO**
Remarks:

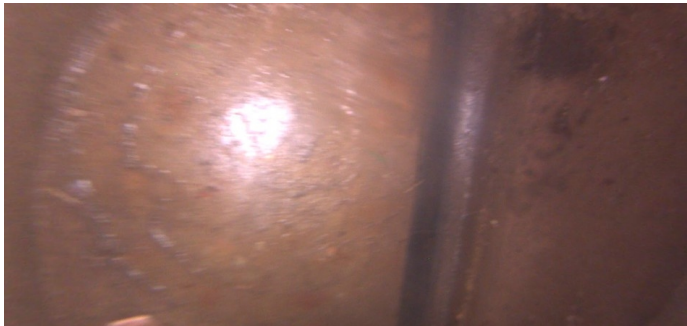
Code: **MGO**
Description: **General Observation**

Distance (ft): **3.4**
Structural Grade: **0**
O&M Grade: **0**
Clock Start/From:
Clock To:
1st Value:
2nd Value:
Value Percent:
Step: **NO**
Remarks: **Ins. Comp.**
