Manhole Inspection Report

Date:	04/12/2018	Weather:		Coding:	RZMACP
MH#:	M-903-050	Owner:	NA	Len. Surveyed:	5.7
P.O.#:		Surveyor:	John Kuglmaier	Rim to Invert:	6.9
Customer:		Cert. #:	U-1215-07002349	Wall Material:	Concrete (reinforced)

Street:	Wisconsin St. 29' North of 40th Plac	Project:	Hobart, IN
City:	Hobart, IN	GPS Northing:	2909709.253
Location:		GPS Easting:	2909709.253
Drain Area:	Northwest	GPS Accuracy:	Sub-Meter
Cover Shape:	Circular	Evidence of Surcharge:	Yes
Cover Size:	23.0	Potential for Runoff:	None
Comments:

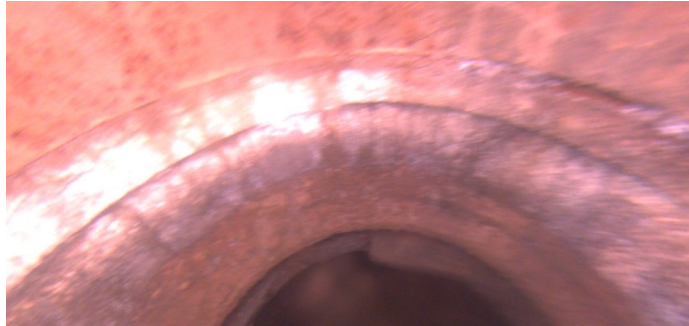
Code:	DAZ
Description:	Deposits Attached Other
Distance (ft):	.4
Structural Grade:	0
O&M Grade:	2
Clock Start/From:	12
Clock To:	12
1st Value:	
2nd Value:	
Value Percent:	5.000
Step:	NO
Remarks:	Mixed materials

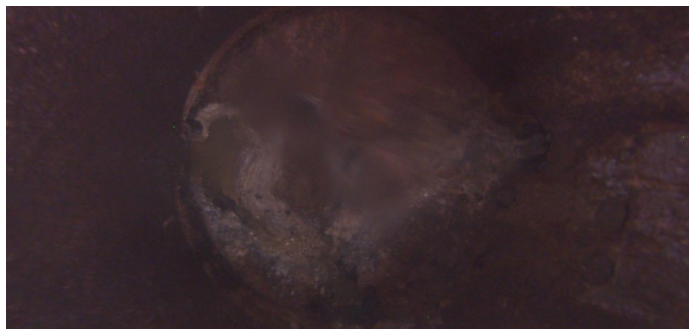
Code:	DAZ
Description:	Deposits Attached Other
Distance (ft):	2.9
Structural Grade:	0
O&M Grade:	3
Clock Start/From:	12
Clock To:	12
1st Value:	
2nd Value:	
Value Percent:	15.000
Step:	NO
Remarks:	Mixed materials

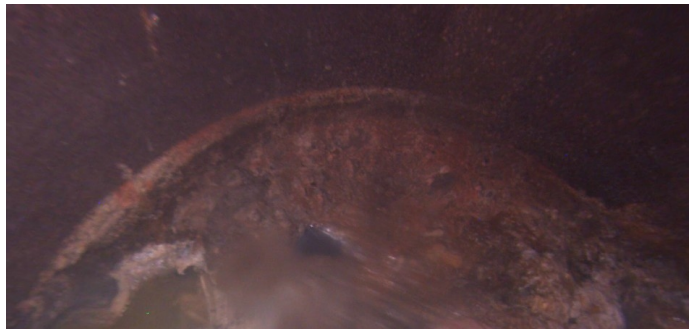
Code:	DAZ
Description:	Deposits Attached Other
Distance (ft):	4.4
Structural Grade:	0
O&M Grade:	2
Clock Start/From:	12
Clock To:	12
1st Value:	
2nd Value:	
Value Percent:	5.000
Step:	NO
Remarks:	Mixed materials
