# Manhole Inspection Report

Date:	<b>03/21/2018</b>	Weather:		Coding:	<b>RZMACP</b>
MH#:	<b>M-903-051</b>	Owner:	<b>NA</b>	Len. Surveyed:	<b>3.3</b>
P.O.#:		Surveyor:	<b>John Kuglmaier</b>	Rim to Invert:	<b>4.5</b>
Customer:		Cert. #:	<b>U-1215-07002349</b>	Wall Material:	<b>Concrete (reinforced)</b>

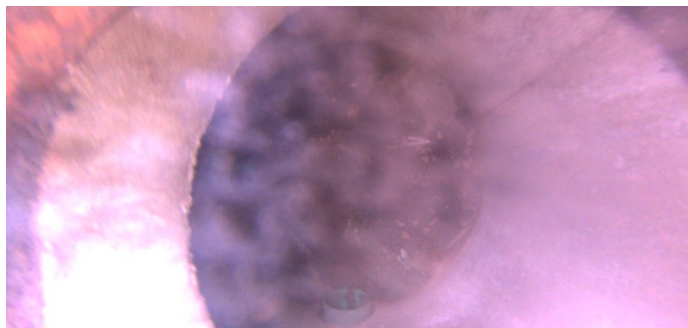
Code: **MGP**  
Description: **General Photo**

Distance (ft): **.0**  
Structural Grade: **0**  
O&M Grade: **0**  
Clock Start/From:  
Clock To:  
1st Value:  
2nd Value:  
Value Percent:  
Step: **NO**  
Remarks:

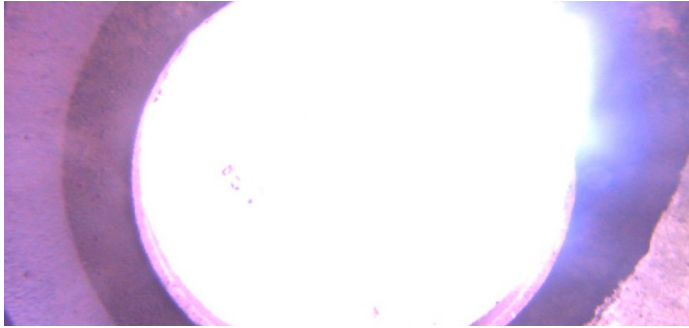
Code:	<b>MGP</b>
Description:	<b>General Photo</b>
Distance (ft):	<b>1.4</b>
Structural Grade:	<b>0</b>
O&M Grade:	<b>0</b>
Clock Start/From:	
Clock To:	
1st Value:	
2nd Value:	
Value Percent:	
Step:	<b>NO</b>
Remarks:

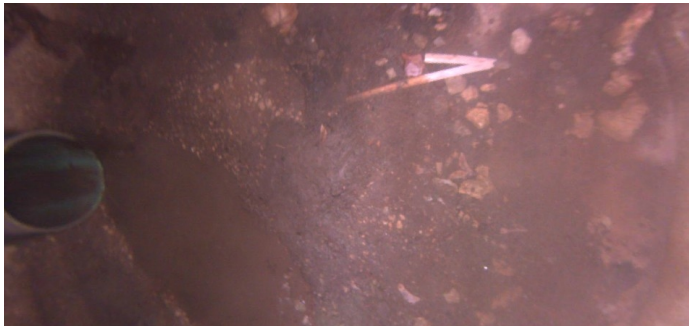
Code:	<b>MGO</b>
Description:	<b>General Observation</b>
Distance (ft):	<b>2.7</b>
Structural Grade:	<b>0</b>
O&M Grade:	<b>0</b>
Clock Start/From:	
Clock To:	
1st Value:	
2nd Value:	
Value Percent:	
Step:	<b>NO</b>
Remarks:	<b>Ins. Comp.</b>
