Manhole Inspection Report

Date:	03/21/2018	Weather:		Coding:	RZMACP
MH#:	M-903-052	Owner:	NA	Len. Surveyed:	3.1
P.O.#:		Surveyor:	John Kuglmaier	Rim to Invert:	4.0
Customer:		Cert. #:	U-1215-07002349	Wall Material:	Concrete (reinforced)

Street:	652' South of Hwy 6. 1304' East of H	Project:	Hobart, IN
City:	Hobart, IN	GPS Northing:	0.0
Location:		GPS Easting:	0.0
Drain Area:	Northeast	GPS Accuracy:	Nearest Meter
Cover Shape:	Circular	Evidence of Surcharge:	Yes
Cover Size:	23.0	Potential for Runoff:	None
Comments:

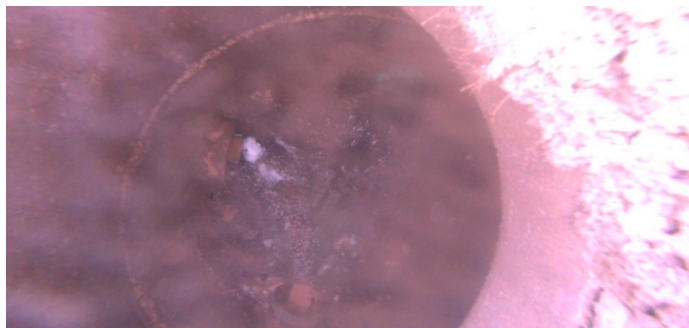
Code: **MGP**
Description: **General Photo**

Distance (ft): **.0**
Structural Grade: **0**
O&M Grade: **0**
Clock Start/From:
Clock To:
1st Value:
2nd Value:
Value Percent:
Step: **NO**
Remarks:

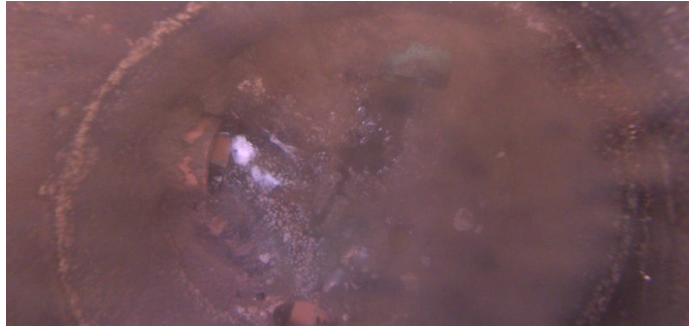
Code: **DAZ**
Description: **Deposits Attached Other**

Distance (ft): **.7**
Structural Grade: **0**
O&M Grade: **2**
Clock Start/From: **12**
Clock To: **12**
1st Value:
2nd Value:
Value Percent: **10.000**
Step: **NO**
Remarks: **Mixed materials**

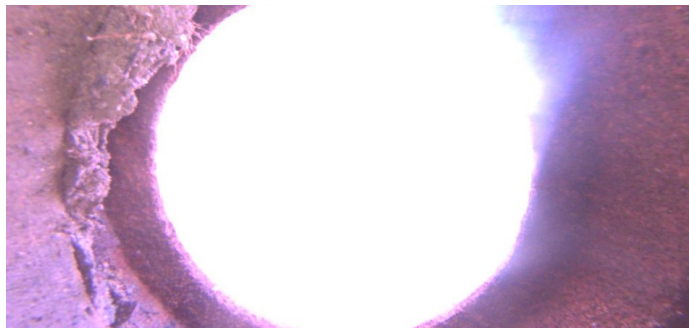
Code: **MGP**
Description: **General Photo**

Distance (ft): **1.3**
Structural Grade: **0**
O&M Grade: **0**
Clock Start/From:
Clock To:
1st Value:
2nd Value:
Value Percent:
Step: **NO**
Remarks:

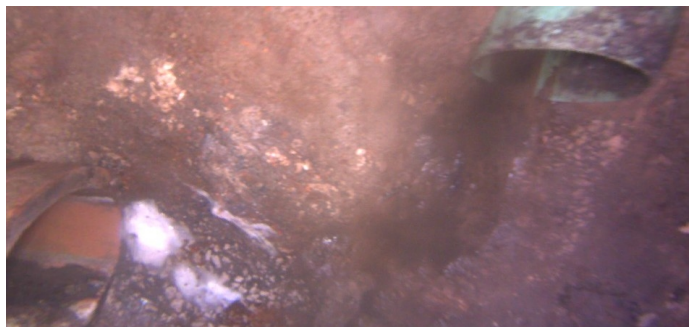
Code: **MGO**
Description: **General Observation**

Distance (ft): **2.5**
Structural Grade: **0**
O&M Grade: **0**
Clock Start/From:
Clock To:
1st Value:
2nd Value:
Value Percent:
Step: **NO**
Remarks: **Ins. Comp.**
