Manhole Inspection Report

Date:	03/21/2018	Weather:		Coding:	RZMACP
MH#:	M-903-053	Owner:	NA	Len. Surveyed:	4.0
P.O.#:		Surveyor:	John Kuglmaier	Rim to Invert:	5.4
Customer:		Cert. #:	U-1215-07002349	Wall Material:	Concrete (reinforced)

Street:	652' South of Hwy 6. 911' East of H	Project:	Hobart, IN
City:	Hobart, IN	GPS Northing:	0.0
Location:		GPS Easting:	0.0
Drain Area:	Northeast	GPS Accuracy:	Nearest Meter
Cover Shape:	Circular	Evidence of Surcharge:	No
Cover Size:	23.0	Potential for Runoff:	None
Comments:

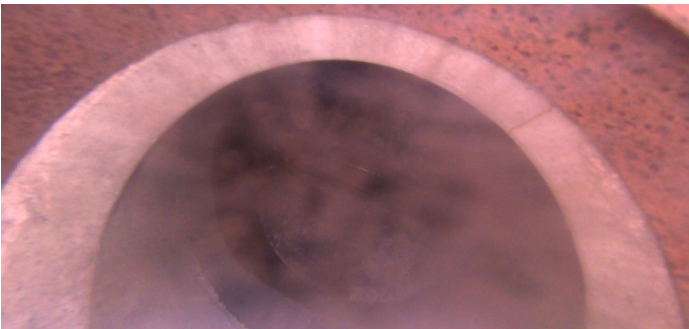
Code: **MGP**
Description: **General Photo**

Distance (ft): **.0**
Structural Grade: **0**
O&M Grade: **0**
Clock Start/From:
Clock To:
1st Value:
2nd Value:
Value Percent:
Step: **NO**
Remarks:

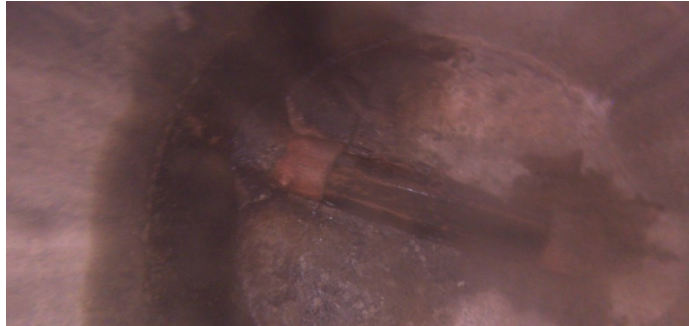
Code: **IS**
Description: **Infil Stain**

Distance (ft): **1.8**
Structural Grade: **0**
O&M Grade: **0**
Clock Start/From: **9**
Clock To: **3**
1st Value:
2nd Value:
Value Percent:
Step: **NO**
Remarks:

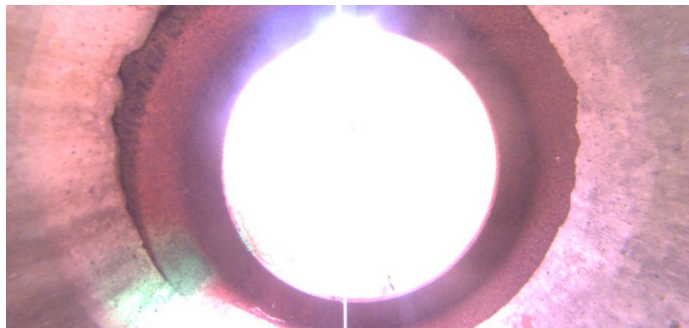
Code: **MGP**
Description: **General Photo**

Distance (ft): **1.9**
Structural Grade: **0**
O&M Grade: **0**
Clock Start/From:
Clock To:
1st Value:
2nd Value:
Value Percent:
Step: **NO**
Remarks:

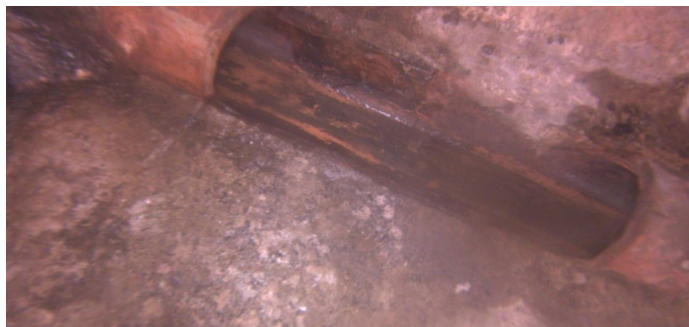
Code: **MGO**
Description: **General Observation**

Distance (ft): **3.3**
Structural Grade: **0**
O&M Grade: **0**
Clock Start/From:
Clock To:
1st Value:
2nd Value:
Value Percent:
Step: **NO**
Remarks: **Ins. Comp.**
