Manhole Inspection Report

Date:	03/21/2018	Weather:		Coding:	RZMACP
MH#:	M-903-054	Owner:	NA	Len. Surveyed:	4.3
P.O.#:		Surveyor:	John Kuglmaier	Rim to Invert:	5.2
Customer:		Cert. #:	U-1215-07002349	Wall Material:	Concrete (reinforced)

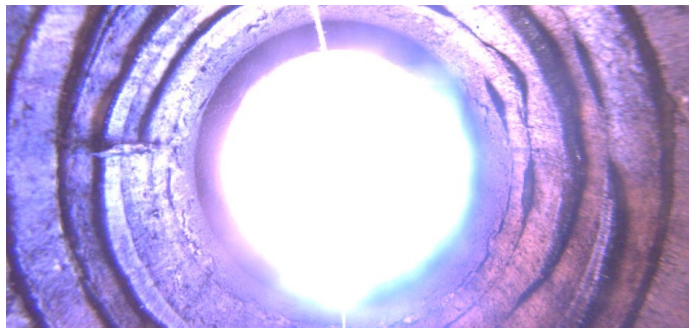
Code:	DAZ
Description:	Deposits Attached Other
Distance (ft):	1.8
Structural Grade:	0
O&M Grade:	2
Clock Start/From:	12
Clock To:	12
1st Value:	
2nd Value:	
Value Percent:	5.000
Step:	NO
Remarks:	Mixed materials
