Manhole Inspection Report

Date:	03/21/2018	Weather:		Coding:	RZMACP
MH#:	M-903-055	Owner:	NA	Len. Surveyed:	5.3
P.O.#:		Surveyor:	John Kuglmaier	Rim to Invert:	6.4
Customer:		Cert. #:	U-1215-07002349	Wall Material:	Concrete (reinforced)

Street:	475' South of Hwy 6. 608' East of H	Project:	Hobart, IN
City:	Hobart, IN	GPS Northing:	0.0
Location:		GPS Easting:	0.0
Drain Area:	Northeast	GPS Accuracy:	Nearest Meter
Cover Shape:	Circular	Evidence of Surcharge:	Yes
Cover Size:	23.0	Potential for Runoff:	None
Comments:

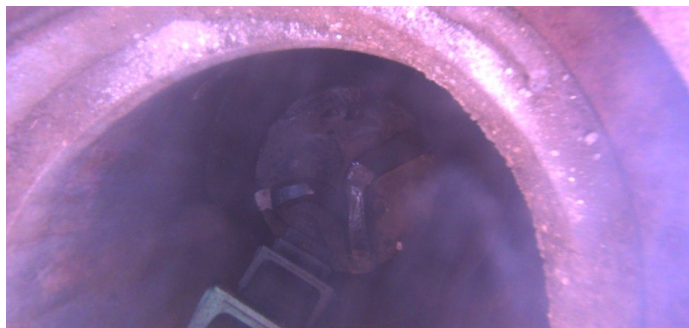
Code: **MGP**
Description: **General Photo**

Distance (ft): **.0**
Structural Grade: **0**
O&M Grade: **0**
Clock Start/From:
Clock To:
1st Value:
2nd Value:
Value Percent:
Step: **NO**
Remarks:

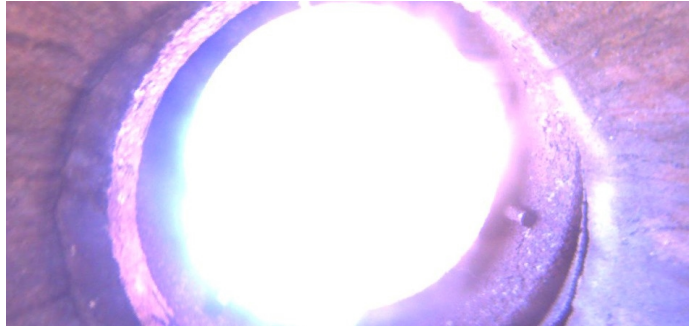
Code: **MGP**
Description: **General Photo**

Distance (ft): **2.2**
Structural Grade: **0**
O&M Grade: **0**
Clock Start/From:
Clock To:
1st Value:
2nd Value:
Value Percent:
Step: **NO**
Remarks:

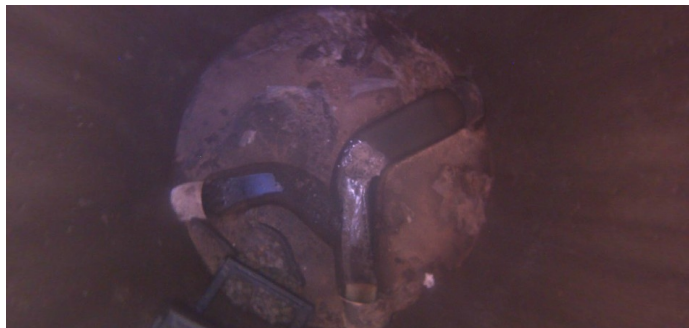
Code: **DAZ**
Description: **Deposits Attached Other**

Distance (ft): **2.6**
Structural Grade: **0**
O&M Grade: **2**
Clock Start/From: **12**
Clock To: **12**
1st Value:
2nd Value:
Value Percent: **10.000**
Step: **NO**
Remarks: **Mixed materials**

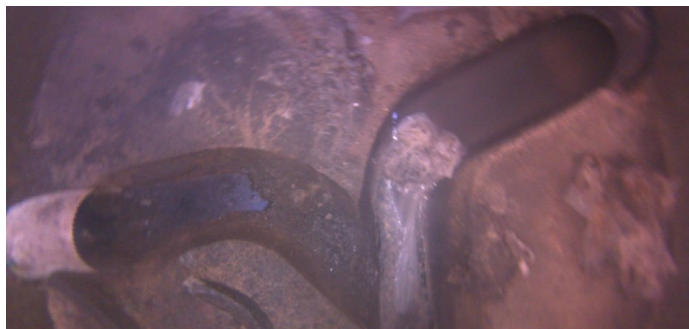
Code: **MGO**
Description: **General Observation**

Distance (ft): **4.4**
Structural Grade: **0**
O&M Grade: **0**
Clock Start/From:
Clock To:
1st Value:
2nd Value:
Value Percent:
Step: **NO**
Remarks: **Ins. Comp.**
