Manhole Inspection Report

Date:	03/21/2018	Weather:		Coding:	RZMACP
MH#:	M-903-059	Owner:	NA	Len. Surveyed:	3.5
P.O.#:		Surveyor:	John Kuglmaier	Rim to Invert:	4.6
Customer:		Cert. #:	U-1215-07002349	Wall Material:	Concrete (reinforced)

Street:	302' South of Hwy 6. 982' East of H	Project:	Hobart, IN
City:	Hobart, IN	GPS Northing:	0.0
Location:		GPS Easting:	0.0
Drain Area:	Northeast	GPS Accuracy:	Nearest Meter
Cover Shape:	Circular	Evidence of Surcharge:	No
Cover Size:	23.0	Potential for Runoff:	None
Comments:

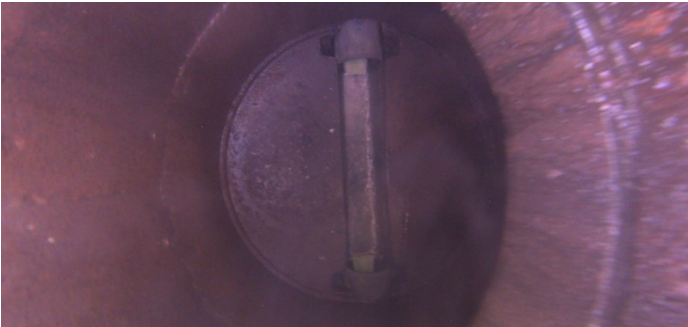
MGP

General Photo

.0

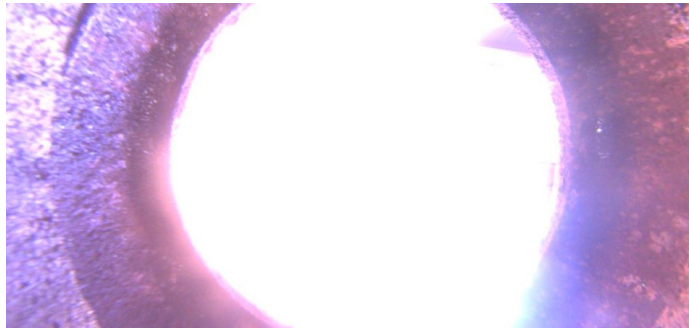
Code: **MGP**
Description: **General Photo**

Distance (ft): **1.6**
Structural Grade: **0**
O&M Grade: **0**
Clock Start/From:
Clock To:
1st Value:
2nd Value:
Value Percent:
Step: **NO**
Remarks:

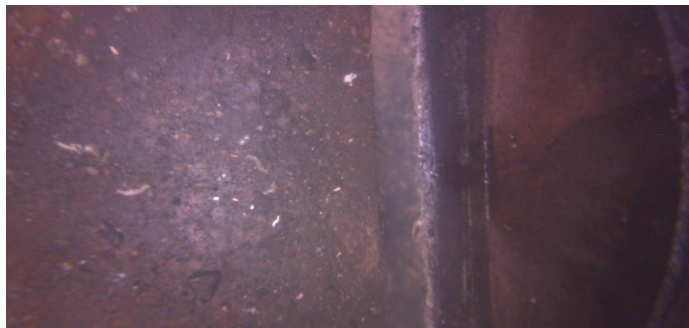
Code: **MGO**
Description: **General Observation**

Distance (ft): **2.6**
Structural Grade: **0**
O&M Grade: **0**
Clock Start/From:
Clock To:
1st Value:
2nd Value:
Value Percent:
Step: **NO**
Remarks: **Ins. Comp.**
