Manhole Inspection Report

Date:	03/21/2018	Weather:		Coding:	RZMACP
MH#:	M-903-060	Owner:	NA	Len. Surveyed:	2.1
P.O.#:		Surveyor:	John Kuglmaier	Rim to Invert:	3.1
Customer:		Cert. #:	U-1215-07002349	Wall Material:	Concrete (reinforced)

Street:	304' South of Hwy 6. 1302' East of H	Project:	Hobart, IN
City:	Hobart, IN	GPS Northing:	0.0
Location:		GPS Easting:	0.0
Drain Area:	Northeast	GPS Accuracy:	Nearest Meter
Cover Shape:	Circular	Evidence of Surcharge:	No
Cover Size:	23.0	Potential for Runoff:	None
Comments:

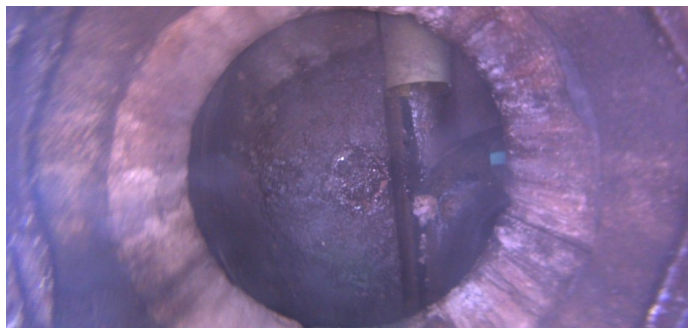
Code: **MGP**
Description: **General Photo**

Distance (ft): **.0**
Structural Grade: **0**
O&M Grade: **0**
Clock Start/From:
Clock To:
1st Value:
2nd Value:
Value Percent:
Step: **NO**
Remarks:

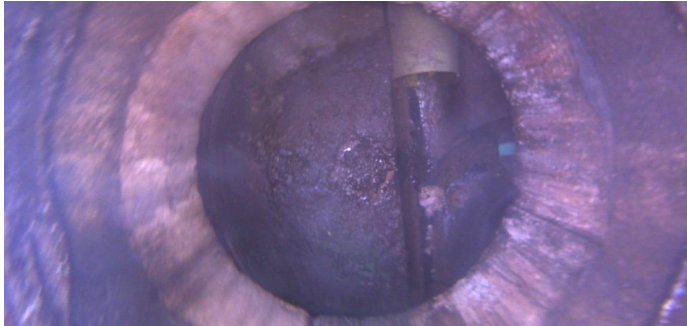
Code: **DSF**
Description: **Deposits Settled Fine**

Distance (ft): **.0**
Structural Grade: **0**
O&M Grade: **2**
Clock Start/From: **12**
Clock To: **12**
1st Value:
2nd Value:
Value Percent: **5.000**
Step: **NO**
Remarks:

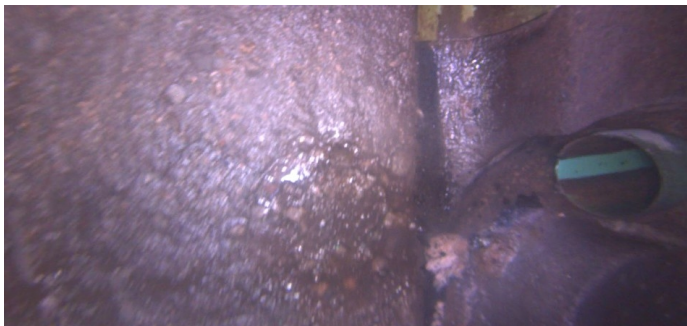
Code: **MGO**
Description: **General Observation**

Distance (ft): **1.6**
Structural Grade: **0**
O&M Grade: **0**
Clock Start/From:
Clock To:
1st Value:
2nd Value:
Value Percent:
Step: **NO**
Remarks: **Ins. Comp.**
