Manhole Inspection Report

Date:	03/21/2018	Weather:		Coding:	RZMACP
MH#:	M-903-061	Owner:	NA	Len. Surveyed:	2.5
P.O.#:		Surveyor:	John Kuglmaier	Rim to Invert:	4.0
Customer:		Cert. #:	U-1215-07002349	Wall Material:	Concrete (reinforced)

Street:	228' South of Hwy 6. 983' West of U	Project:	Hobart, IN
City:	Hobart, IN	GPS Northing:	0.0
Location:		GPS Easting:	0.0
Drain Area:	Northeast	GPS Accuracy:	Nearest Meter
Cover Shape:	Circular	Evidence of Surcharge:	Yes
Cover Size:	23.0	Potential for Runoff:	None
Comments:

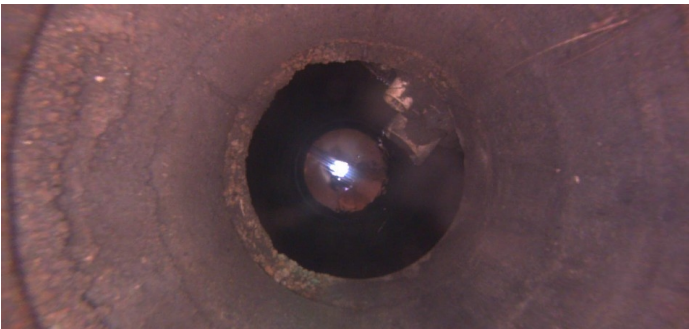
Code: **MGP**
 Description: **General Photo**

Distance (ft): **.0**
 Structural Grade: **0**
 O&M Grade: **0**
 Clock Start/From:
 Clock To:
 1st Value:
 2nd Value:
 Value Percent:
 Step: **NO**
 Remarks:

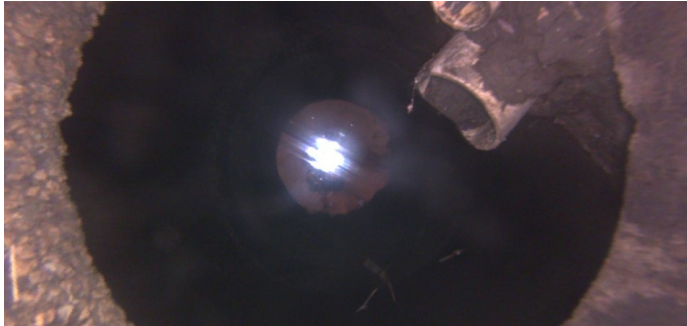
Code:	MGO
Description:	General Observation
Distance (ft):	1.6
Structural Grade:	0
O&M Grade:	0
Clock Start/From:	
Clock To:	
1st Value:	
2nd Value:	
Value Percent:	
Step:	NO
Remarks:	Surcharge

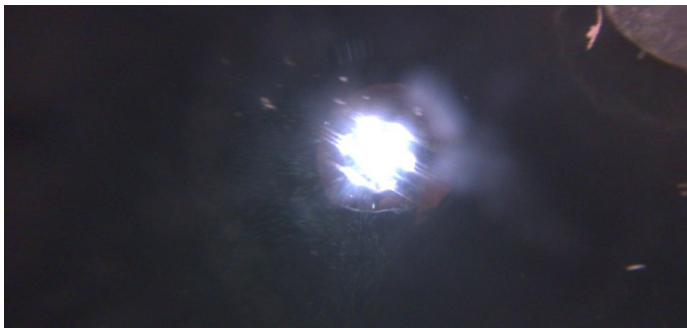
Code:	MSA
Description:	Abandoned Survey
Distance (ft):	2.3
Structural Grade:	0
O&M Grade:	0
Clock Start/From:	
Clock To:	
1st Value:	
2nd Value:	
Value Percent:	
Step:	NO
Remarks:	Surcharge
