Manhole Inspection Report

Date:	03/21/2018	Weather:		Coding:	RZMACP
MH#:	M-903-062	Owner:	NA	Len. Surveyed:	2.3
P.O.#:		Surveyor:	John Kuglmaier	Rim to Invert:	3.3
Customer:		Cert. #:	U-1215-07002349	Wall Material:	Concrete (reinforced)

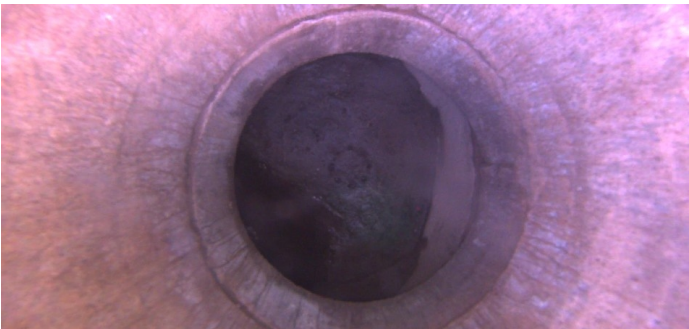
Code: **MGP**
 Description: **General Photo**

Distance (ft): **.0**
 Structural Grade: **0**
 O&M Grade: **0**
 Clock Start/From:
 Clock To:
 1st Value:
 2nd Value:
 Value Percent:
 Step: **NO**
 Remarks:

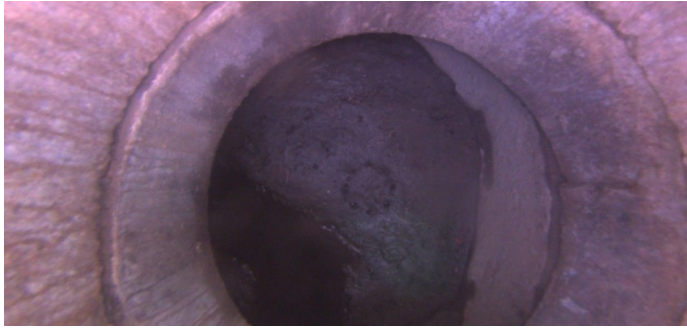
Code:	DSF
Description:	Deposits Settled Fine
Distance (ft):	.7
Structural Grade:	0
O&M Grade:	3
Clock Start/From:	12
Clock To:	12
1st Value:	
2nd Value:	
Value Percent:	15.000
Step:	NO
Remarks:

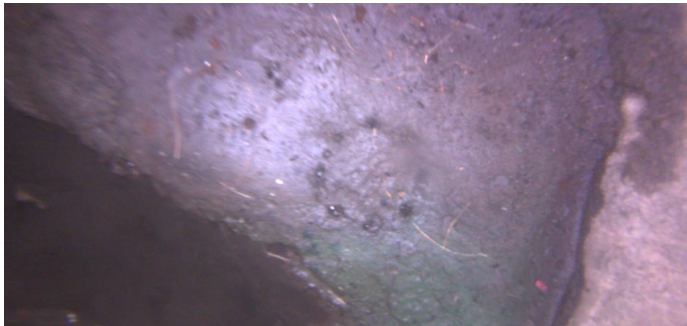
Code:	MGO
Description:	General Observation
Distance (ft):	2.0
Structural Grade:	0
O&M Grade:	0
Clock Start/From:	
Clock To:	
1st Value:	
2nd Value:	
Value Percent:	
Step:	NO
Remarks:	Ins. Comp.
