Manhole Inspection Report

| MH#: | M-903-063 | Owner: | NA | Len. Surveyed: | 3.1 |

| Street: | 432' South of Hwy 6. 932' West of U | Project: | 502259S9MACP26Jan2023 |
| City: | Hobart, IN | GPS Northing: | 2295277.117 |

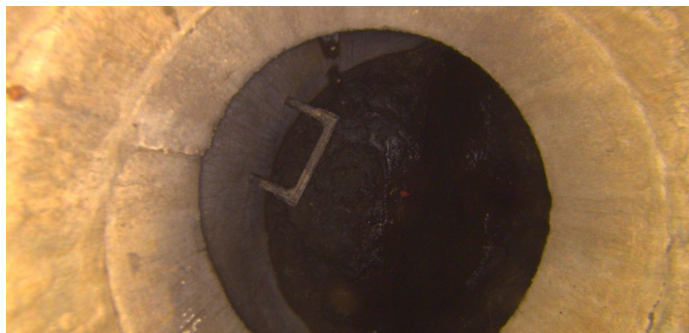
Code: **MGO**
Description: **General Observation**

Distance (ft): **.0**
Structural Grade: **0**
O&M Grade: **0**
Clock Start/From:
Clock To:
1st Value:
2nd Value:
Value Percent:
Step: **NO**
Remarks: **access mh**

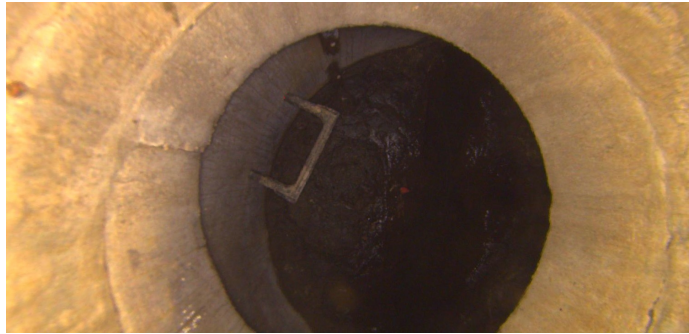
Code: **SRI**
Description: **Surface Roughness Increased**

Distance (ft): **.0**
Structural Grade: **1**
O&M Grade: **0**
Clock Start/From: **12**
Clock To: **12**
1st Value:
2nd Value:
Value Percent:
Step: **NO**
Remarks:

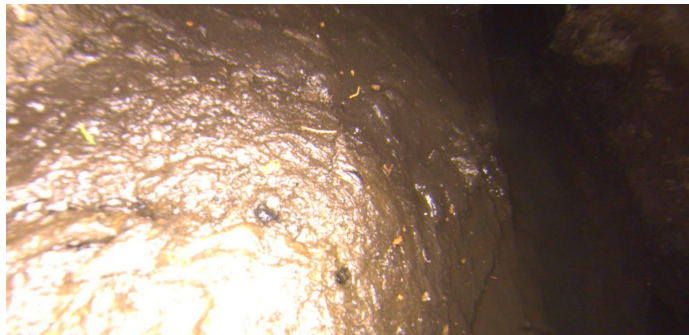
Code: **DSF**
Description: **Deposits Settled Fine**

Distance (ft): **3.1**
Structural Grade: **0**
O&M Grade: **2**
Clock Start/From: **12**
Clock To: **12**
1st Value:
2nd Value:
Value Percent: **10.000**
Step: **NO**
Remarks:

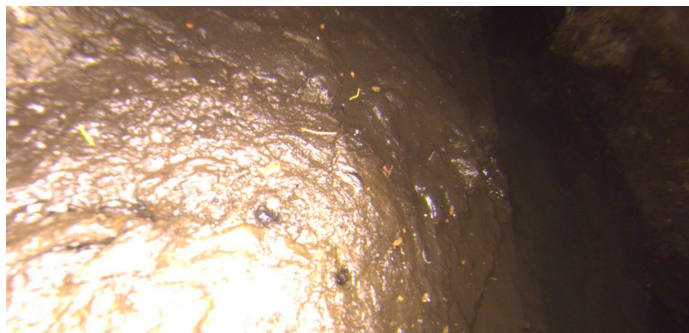
Code: **MGO**
Description: **General Observation**

Distance (ft): **3.1**
Structural Grade: **0**
O&M Grade: **0**
Clock Start/From:
Clock To:
1st Value:
2nd Value:
Value Percent:
Step: **NO**
Remarks: **end of survey**

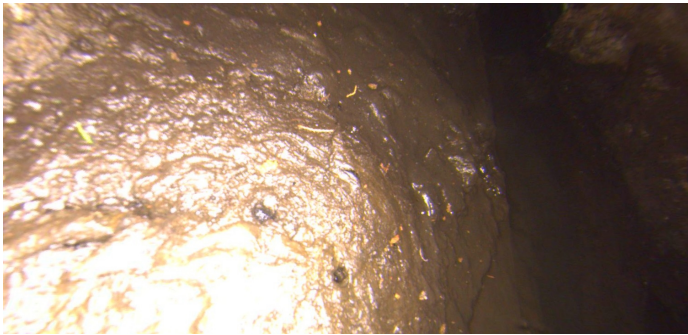
| Code: | SRI |
| Description: | Surface Roughness Increased |
| Distance (ft): | 3.1 |
| Structural Grade: | 1 |
